Experimental Investigation of Load Sharing Behavior for Timber Half-Caps of Toodyay Bridge

Abstract: This study investigates the load sharing capabilities for half-caps of a 190m long timber bridge. The bridge has 31 spans over the Avon River in Toodyay, Western Australia. It was constructed from local hardwood timbers and had a series of repairs. However as the width between kerbs was only 5.5 m and it was no footpath it was decided to replace the bridge by a new wider concrete structure. The proposed removal of the existing bridge provided an opportunity to carry out a research program aimed at bridge inspection, estimation of timber material properties, required for more accurate modeling of structural failure as well as selection of improved repair techniques and strengthening methods. Non-destructive evaluation of the bridge prior to construction of a new one was conducted using trucks to provide both static and dynamic loadings. Half-cap load sharing was examined for north and south loading of the bridge deck at the pier and span positions. This paper deals with the results obtained only the north loading case at the pier position. As Toodyay Bridge 631 is a typical timber b

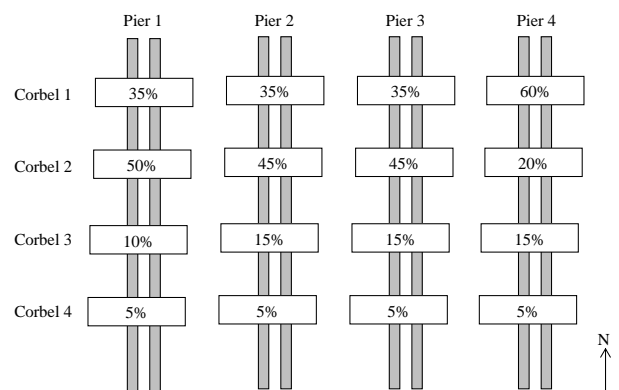
Fig. (5). Load distribution between corbels in toodyay end piers (pier - north loading).

The values, shown in Fig. (5), were determined by averaging the results of the corbel load distribution at each pier for load configurations 1, 2, 3 and 4. The figure shows that the load distributed at each of the corbels is the same for piers 2 and 3. These two piers, however, do not represent the expected values, shown in Fig. (6), as corbel 2 is takes 10% more load than corbel 1. Possible explanation for pier 2, corbel 1, behaving worse than expected, could be attributed to the condition of pile 1.

Possible reasons for pier 3, corbel 1, behaving worse than expected, could also be attributed to the condition of pile 1 and the overlying half-caps. Pile 1 was found to have “major termite damage” to the outer bark layers on two faces of the pile. The western half-cap above pile 1 also contained a horizontal growth ring split. Thus, lower than expected percentage load, distributed to corbel 1, may be due to a combination of the split to the half-cap and the termite damage to the pile.

Pier 1 has a similar corbel percentage load distribution to piers 2 and 3. Corbel 1 was found to take 15% less load than corbel 2, which is most likely due to the condition of pile 1. Pile 1 is shown to have extensive rot to the heartwood, as shown in Fig. (7). It also contains a “knot” approximately 2.2 metres above the waler. Therefore, the load distribution at corbel 1 may have been affected by the deterioration and natural weaknesses in pile 1.

From Fig. (5), it is evident that the load distributed to corbels 1 and 2 in pier 4 are much different to that, found in piers 1, 2 and 3. In comparison to the expected values, shown in Fig. (6), corbel 1 carried approximately 12% more load than expected, and corbel 2 carried 27% less than expected. In all four piers, the percentage load distribution at corbels 3 and 4 were greater than the expected values, shown in Fig. (6). On average, corbels 3 and 4 carried, respectively, 10% and 5% more load than expected. This may be due to the weaknesses and irregularities in the northern end of the

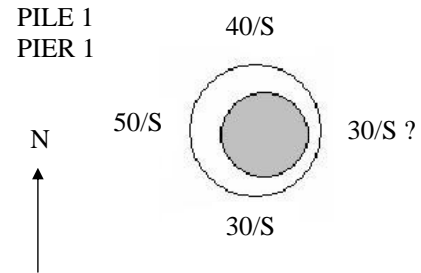
Pile 1 contains no solid timber, as rot has extended throughout the entire thickness of the pile. The deteriorated area of the pile has been shaded, and the numbers on each face of the pile represent how much solid timber remains. Because of the deterioration, a steel column was driven adjacent to pile 1 during the research, to carry the load. Before it was done, it is possible that the half-caps may have settled, resulting in the transfer of a portion of the load to pile 2. Further indicated that there were minor heartwood splits to the half-caps above pile 1. It is possible that it also lead to the transfer of load to corbel 2, as the heartwood is the hardest, most dense wood, and provides the majority of the half-caps stiffness. Hence, any damage or deterioration to the heartwood can reduce the strength of the half-caps [15].

Fig. (7). Section view of rot to pile 1 on pier.

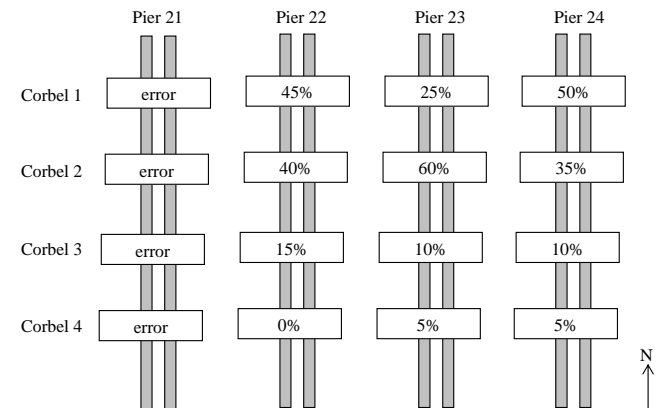
Fig. (8). Load distribution between corbels in Goomalling end piers (pier - north loading).

As it can be followed from Fig. (8), under north loading the corbel load distribution at the Goomalling end of the bridge is much different, compared to that, found at the Toodyay end. It is evident that corbels 1 and 2 in pier 22 supported slightly less loads than the expected values (see Fig. 6). This load was transferred to corbel 3, which supported approximately 10% more load than expected. Possible reasons for the northern corbels in pier 22 performing worse than expected can be found in Fig. (9). There was termite damage to the half-caps above pile 1 (see Fig. 9). There was also deterioration to pile 1 in pier 22, however, a universal column had been driven adjacent to pile 1 to support the load.

By analyzing the results, presented in Fig. (8), it can be concluded that the percentage load distribution at corbels 1 and 2 in pier 23 significantly differs from the expected values, shown in Fig. (5). Corbel 1 supported approximately 23% less load than expected. The load was transferred and supported by corbel 2. Possible reasons for the northern corbel in pier 23, behaving worse than expected, is due to the condition of the half-caps above pile 1.

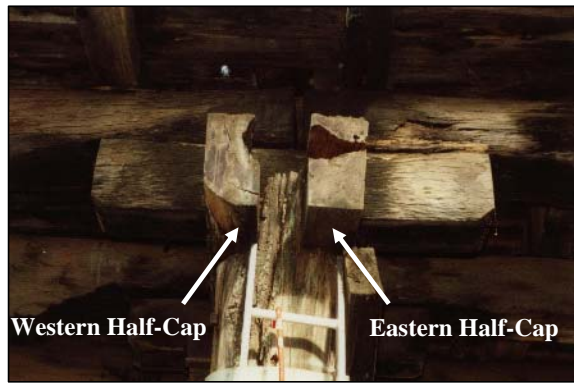
Fig. (9). Termite damage to half-caps above pile 1 on pier 22.

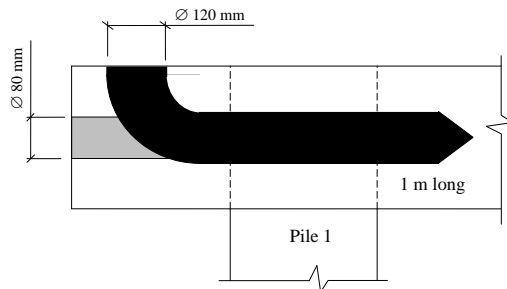
During inspection of the bridge 631, a large “pipe”, located in the eastern half-cap, at the southern end of pier 23, was observed. This pipe was caused by deterioration (or rotting) of a tubular section of timber within the half-cap. This form of deterioration can reduce the strength of the half-cap significantly, affecting the distribution of load to the corbel. The pipe was approximately 120 mm in diameter and 1 m in length, as illustrated in Fig. (10). The values, obtained from the corbel load sharing analysis, at the southern end of pier 23, were similar to those, found at the other piers. Therefore it appears that the pipe in the half-cap did not affect the load sharing at the southern corbels in pier 23.

Fig. (10). Large “pipe” in the eastern half-cap above pile 3 at pier 23.

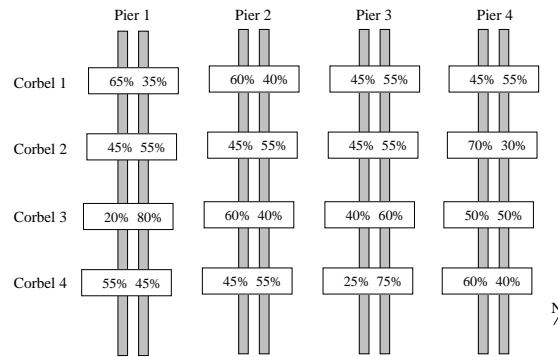
Fig. (13). Load distributed between the eastern and western half-caps in the Toodyay end piers (pier - north loading).

Fig. (13) shows that the load sharing ratios at corbels 2 and 4 in pier 1 have the same range, but they are much different to the ratios, found at corbels 1 and 3. The unexpected load sharing ratio at corbel 3 may be attributed to the condition of pile 3 and the western half-cap. Investigation of the bridge members after testing indicated that the top of pile 3 had deteriorated more on the western side. It was also found that the underside of the western half-cap had weathered where it sits upon pile 3, as shown in Fig. (14).

In pier 2, corbels 2 and 4 had load sharing ratios, which were similar to the expected values. Corbels 1 and 3 also had the same load sharing ratios, but only 40% of the load was distributed to the eastern half-cap in both cases. The unexpected ratio at corbel 1 may be attributed to the replacement of pile 1. As it was mentioned above, the original timber pile 1 contained no solid timber as rot had extended throughout its entire thickness. The shaded portion in gray in the figure shows the area of the pile affected by rotting, reducing the bearing life of the pile. Prior to the new steel universal column being driven to replace pile 1, it is possible that the half-caps may have settled unevenly, producing an uneven distribution of load between the half-caps.

It is evident from Fig. (13) that the northern corbels in pier 3 had different load sharing ratios, compared to the southern one. Northern corbels 1 and 2 had load sharing ratios, which were similar to the expected values. The southern corbels 3 and 4 were found to have uneven load sharing ratios. In particular, at corbel 4 only 25% of the load was distributed to the western half-cap. In pier 4, corbel 3 had the expected 50:50 load sharing ratio, and corbel 1 also had a similar distribution. Corbels 2 and 4, however, had uneven load sharing ratios with the western half-caps supporting a greater percentage of the load. Possible reasons for unexpected behaviour of corbel 4 could be the condition of pile 3.

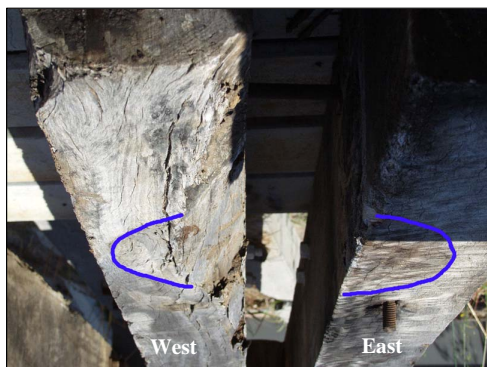
A combination of the deterioration to the half-cap and the top of pile 3 produced an uneven surface for the western half-cap to sit upon. Although this has not affected the load sharing ratio at corbel 4, it may be the cause of the unexpected values, obtained at corbel 3, as the western half-cap was found to support only 20% of the load. Fig. (14) demonstrates that these observations did not affect the load sharing at corbel 4.

Fig. (14). Condition of the underside of the western half-cap on pier 1, pile 3.

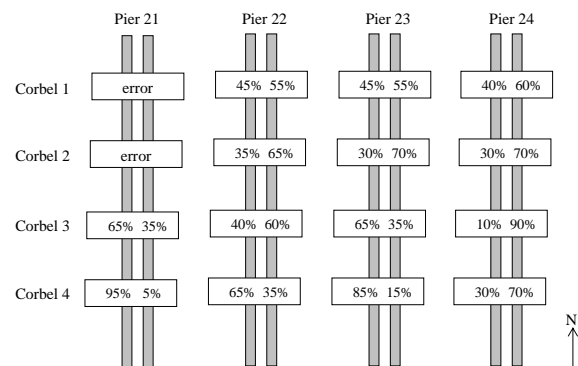
Fig. (15). Load distributed between the eastern and western half-caps in the Goomalling end piers (north loading).

From Fig. (15) it is evident that corbels 3 and 4 in pier 21 do not behave as expected. In particular, at corbel 4 the eastern half-cap supported only 5% of the load. The MRWA Inspection Report [9] and the observations, made during testing, did not indicate that there was any damage to the southern end of pier 21. However, inspection of the bridge structure after testing revealed a large crack at the entire length of the underside of the eastern half-cap. This crack is shown at the northern end of pier 21 in Fig. (16). It is the likely cause of the lower than expected distribution at the southern corbels.

Corbel 1 in pier 22 had a similar load sharing ratio to the expected values, whereas corbels 2, 3 and 4 were found to have unequal load distributions. It was also observed during testing that the eastern half-cap at the southern end of pier 22 was not vertical and as a result, could not support as much load as the western half-cap. It has moved up to 5 mm under loading, when the jacking frame was in place. These are the likely reasons for the eastern half-cap supporting less load than expected.

The percentage load distribution to the eastern and western half-caps at corbel 1 in pier 23, were very similar to the expected values. It has not affected the load transferred to the western half-cap as it was only slightly less than expected. In pier 23 the western half-cap at corbel 2 supported only 30% of the load. Fig. (15) indicates that corbel 4 in pier 23 has load sharing values much different than the expected ones. The eastern half-cap was found to support on average only 15% of the load. The likely cause of this is the large pipe that was located in the eastern half-cap at the southern end of pier 23 (see Fig. 10). This pipe has reduced the cross-sectional area of the eastern half-cap, and in turn, caused a reduction in its transverse compressive stiffness. This explains why the majority of the load was supported by the stiffer western half-cap. The pipe may have also contributed towards the lower than expected distribution of load to the eastern half-cap at corbel 3.

From Fig. (15) it can be seen that the load sharing percentages at all four corbels in pier 24 are very different from the expected values. At all four corbels the lowest percentage of load was distributed to the western half-cap indicating that it possibly contained a flaw or weakness. The western half-cap supported 40% of the load at corbel 1, 30% at corbels 2 and 4, and only 10% at corbel 3. The MRWA Inspection Report [9] did not indicate that there were any weaknesses in either half-cap, and neither did the observations that were made during testing. However, upon completion of the testing, inspection of the bridge structure revealed a large crack running down the inside of the western half-cap, as shown in Fig. (17).

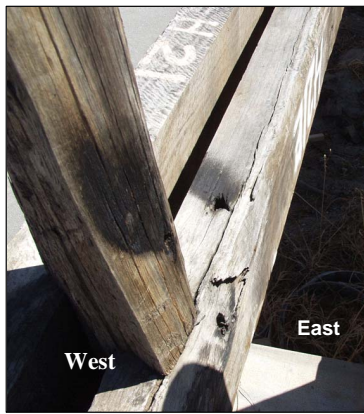
Fig. (16). Crack on the underside of the eastern half-cap at pier 21.

As explained previously, inspection of the bridge members after testing revealed a large crack, running down the underside of the eastern half-cap at pier 21. The damage to the eastern half-cap affected the local load sharing at corbels 3 and 4, with more load being distributed to the stiffer western half-cap. As the total pier half-cap load sharing was determined using the valid load cell readings at corbels 3 and 4, the approximated load distribution for pier 21 will also reflect this damage. Hence, it is likely that only 25% of the load would be distributed to the eastern half-cap as a result of the large crack.

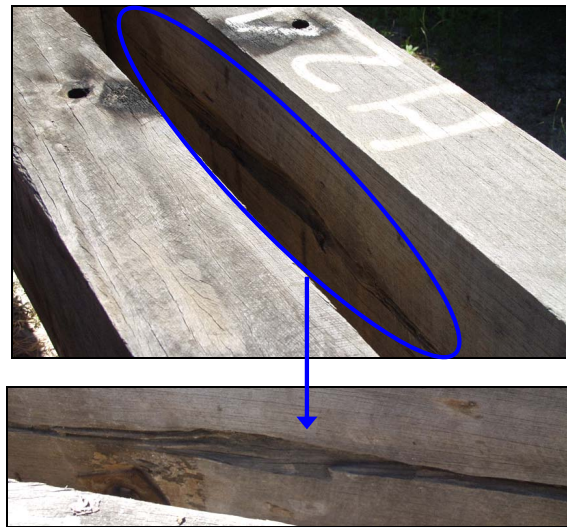
Fig. (17). Crack at the inside face of the western half-cap on pier 24.
