Experimental Investigation of Load Sharing Behavior for Timber Half-Caps of Toodyay Bridge

Abstract: This study investigates the load sharing capabilities for half-caps of a 190m long timber bridge. The bridge has 31 spans over the Avon River in Toodyay, Western Australia. It was constructed from local hardwood timbers and had a series of repairs. However as the width between kerbs was only 5.5 m and it was no footpath it was decided to replace the bridge by a new wider concrete structure. The proposed removal of the existing bridge provided an opportunity to carry out a research program aimed at bridge inspection, estimation of timber material properties, required for more accurate modeling of structural failure as well as selection of improved repair techniques and strengthening methods. Non-destructive evaluation of the bridge prior to construction of a new one was conducted using trucks to provide both static and dynamic loadings. Half-cap load sharing was examined for north and south loading of the bridge deck at the pier and span positions. This paper deals with the results obtained only the north loading case at the pier position. As Toodyay Bridge 631 is a typical timber b

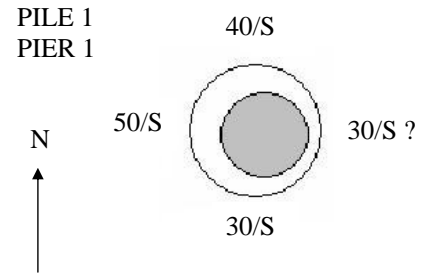
Pile 1 contains no solid timber, as rot has extended throughout the entire thickness of the pile. The deteriorated area of the pile has been shaded, and the numbers on each face of the pile represent how much solid timber remains. Because of the deterioration, a steel column was driven adjacent to pile 1 during the research, to carry the load. Before it was done, it is possible that the half-caps may have settled, resulting in the transfer of a portion of the load to pile 2. Further indicated that there were minor heartwood splits to the half-caps above pile 1. It is possible that it also led to the transfer of load to corbel 2, as the heartwood is the hardest, most dense wood, and provides the majority of the half-caps stiffness. Hence, any damage or deterioration to the heartwood can reduce the strength of the half-caps [15].

Pier 1 has a similar corbel percentage load distribution to piers 2 and 3. Corbel 1 was found to take 15% less load than corbel 2, which is most likely due to the condition of pile 1. Pile 1 is shown to have extensive rot to the heartwood, as shown in Fig. (7). It also contains a “knot” approximately 2.2 metres above the waler. Therefore, the load distribution at corbel 1 may have been affected by the deterioration and natural weaknesses in pile 1.

Fig. (7). Section view of rot to pile 1 on pier.

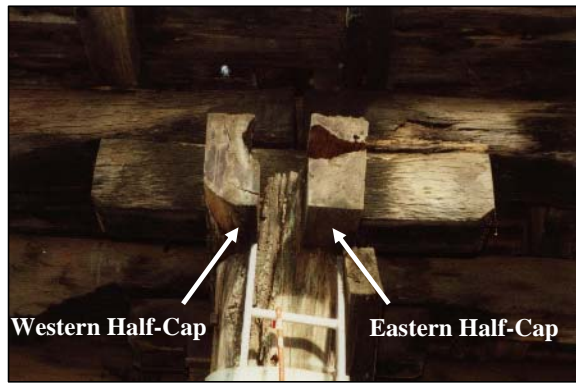
By analyzing the results, presented in Fig. (8), it can be concluded that the percentage load distribution at corbels 1 and 2 in pier 23 significantly differs from the expected values, shown in Fig. (5). Corbel 1 supported approximately 23% less load than expected. The load was transferred and supported by corbel 2. Possible reasons for the northern corbel in pier 23, behaving worse than expected, is due to the condition of the half-caps above pile 1.

Fig. (9). Termite damage to half-caps above pile 1 on pier 22.

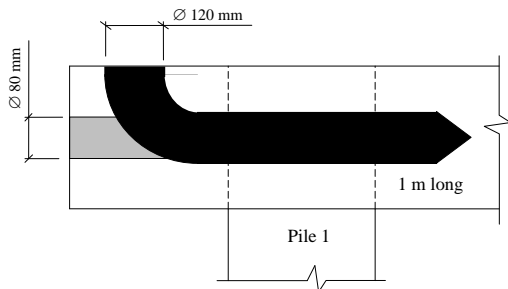
During inspection of the bridge 631, a large “pipe”, located in the eastern half-cap, at the southern end of pier 23, was observed. This pipe was caused by deterioration (or rotting) of a tubular section of timber within the half-cap. This form of deterioration can reduce the strength of the half-cap significantly, affecting the distribution of load to the corbel. The pipe was approximately 120 mm in diameter and 1 m in length, as illustrated in Fig. (10). The values, obtained from the corbel load sharing analysis, at the southern end of pier 23, were similar to those, found at the other piers. Therefore it appears that the pipe in the half-cap did not affect the load sharing at the southern corbels in pier 23.

Fig. (10). Large “pipe” in the eastern half-cap above pile 3 at pier 23.

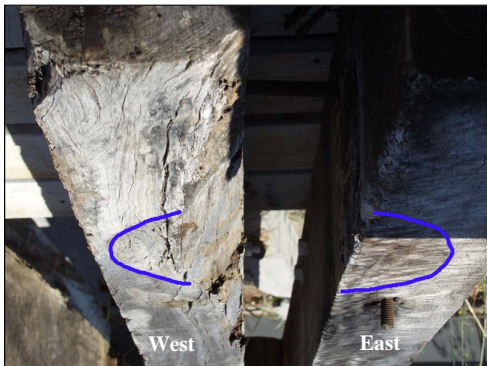
Fig. (13) shows that the load sharing ratios at corbels 2 and 4 in pier 1 have the same range, but they are much different to the ratios, found at corbels 1 and 3. The unexpected load sharing ratio at corbel 3 may be attributed to the condition of pile 3 and the western half-cap. Investigation of the bridge members after testing indicated that the top of pile 3 had deteriorated more on the western side. It was also found that the underside of the western half-cap had weathered where it sits upon pile 3, as shown in Fig. (14).

A combination of the deterioration to the half-cap and the top of pile 3 produced an uneven surface for the western half-cap to sit upon. Although this has not affected the load sharing ratio at corbel 4, it may be the cause of the unexpected values, obtained at corbel 3, as the western half-cap was found to support only 20% of the load. Fig. (14) demonstrates that these observations did not affect the load sharing at corbel 4.

Fig. (14). Condition of the underside of the western half-cap on pier 1, pile 3.

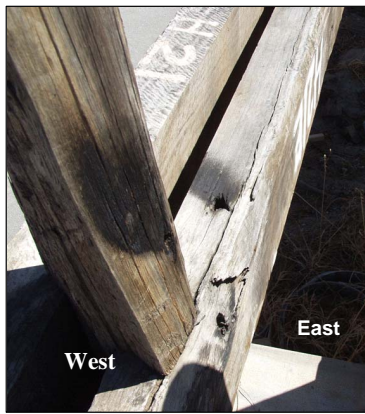
From Fig. (15) it is evident that corbels 3 and 4 in pier 21 do not behave as expected. In particular, at corbel 4 the eastern half-cap supported only 5% of the load. The MRWA Inspection Report [9] and the observations, made during testing, did not indicate that there was any damage to the southern end of pier 21. However, inspection of the bridge structure after testing revealed a large crack at the entire length of the underside of the eastern half-cap. This crack is shown at the northern end of pier 21 in Fig. (16). It is the likely cause of the lower than expected distribution at the southern corbels.

Fig. (16). Crack on the underside of the eastern half-cap at pier 21.

As explained previously, inspection of the bridge members after testing revealed a large crack, running down the underside of the eastern half-cap at pier 21. The damage to the eastern half-cap affected the local load sharing at corbels 3 and 4, with more load being distributed to the stiffer western half-cap. As the total pier half-cap load sharing was determined using the valid load cell readings at corbels 3 and 4, the approximated load distribution for pier 21 will also reflect this damage. Hence, it is likely that only 25% of the load would be distributed to the eastern half-cap as a result of the large crack.

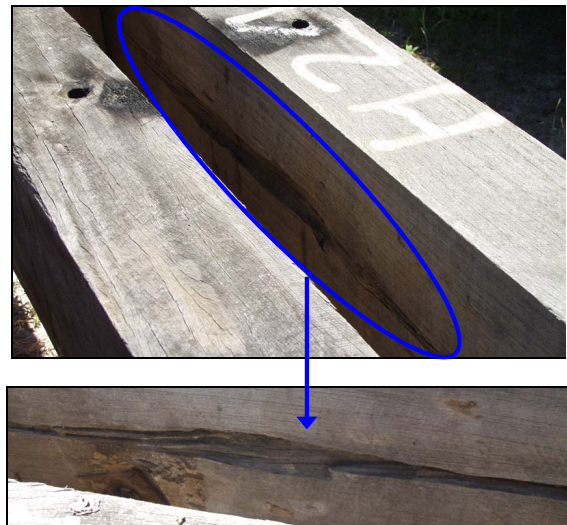
From Fig. (15) it can be seen that the load sharing percentages at all four corbels in pier 24 are very different from the expected values. At all four corbels the lowest percentage of load was distributed to the western half-cap indicating that it possibly contained a flaw or weakness. The western half-cap supported 40% of the load at corbel 1, 30% at corbels 2 and 4, and only 10% at corbel 3. The MRWA Inspection Report [9] did not indicate that there were any weaknesses in either half-cap, and neither did the observations that were made during testing. However, upon completion of the testing, inspection of the bridge structure revealed a large crack running down the inside of the western half-cap, as shown in Fig. (17).

Fig. (17). Crack at the inside face of the western half-cap on pier 24.
