The Open Construction & Building Technology Journal

RESEARCH ARTICLE

An Investigation of a Post-tension Problem in a Conference Hall Roof

Muneer K. Saeed^{1,*}

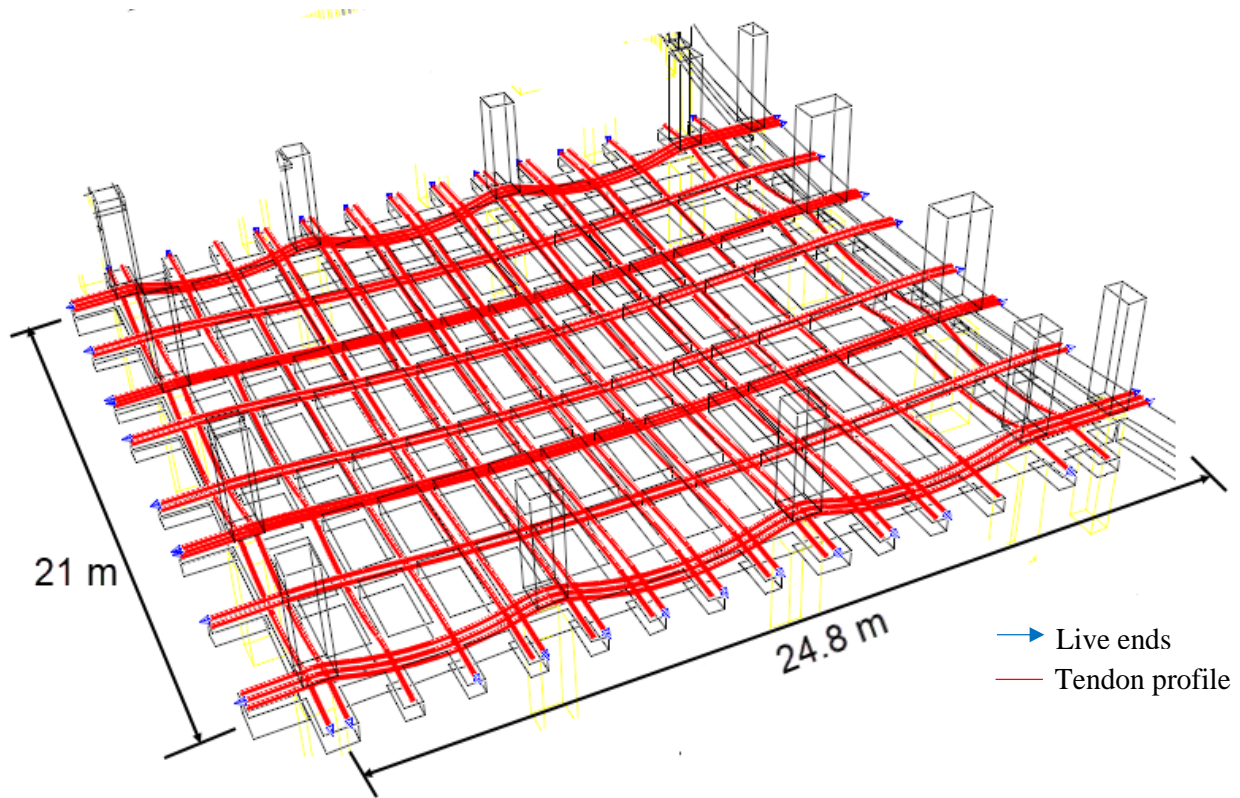
Fig. (1). Post tension system.

In this study, the post-tensioned concrete girders with a top reinforced slab were chosen as the structural roof system for the hall with dimensions of 21m×25 m as shown in Fig. (1).

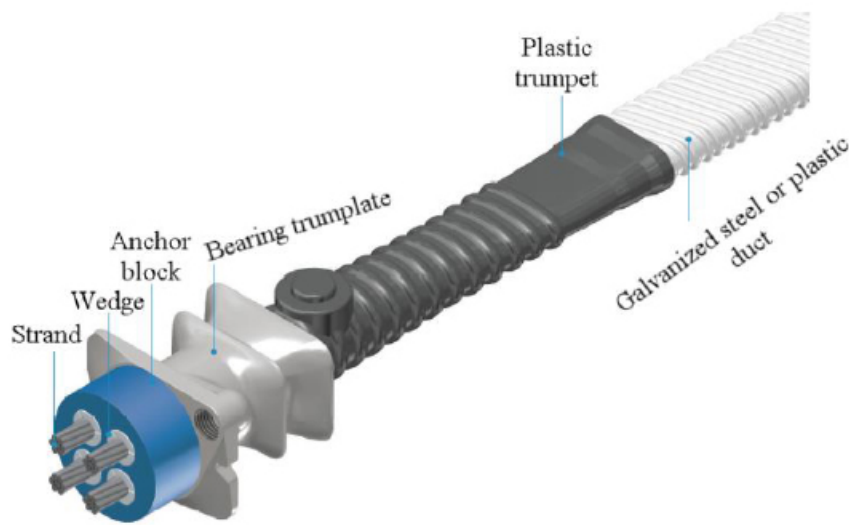
Fig. (2). The European-approved CONA CMF BT post-tensioning system with flat steel duct.

The strands utilized had a diameter of 15.7 mm and a tensile strength of 1860 MPa. The European CON A® CM F post-tensioning system was used as shown in Fig. (2). This system is suitable for thin-concrete sections and having corrugated round or flat tendon ducts utilizing either galvanized steel or plastic material. It has fixed and movable couplers for joining tendons. Table 1 shows the properties of the tendon system. A storage room with a minimum dimension of 12m x 3m was designated for the purpose of storing the PT coils. A maximum of two coils can be vertically stacked on top of one another. The coils were stored on wooden Pallets to avoid soil contact and must be coated with sheeting for further corrosion protection. All anchors, heads, and wedges were stored in a place or container that was not exposed to sunlight, dust, or water.

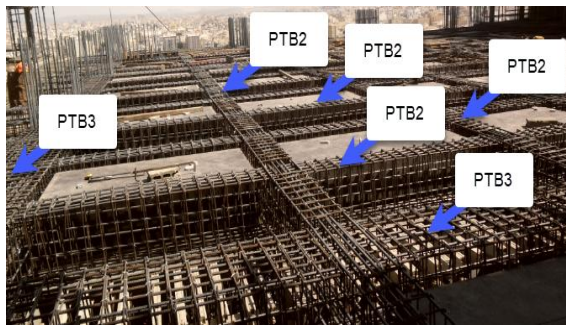
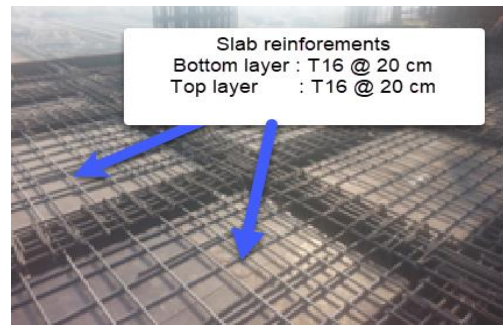
Fig. (4a, b). General view of steel reinforcement works.

a) Installation of Beams Steel Reinforcement

b) Installation of slab reinforcement

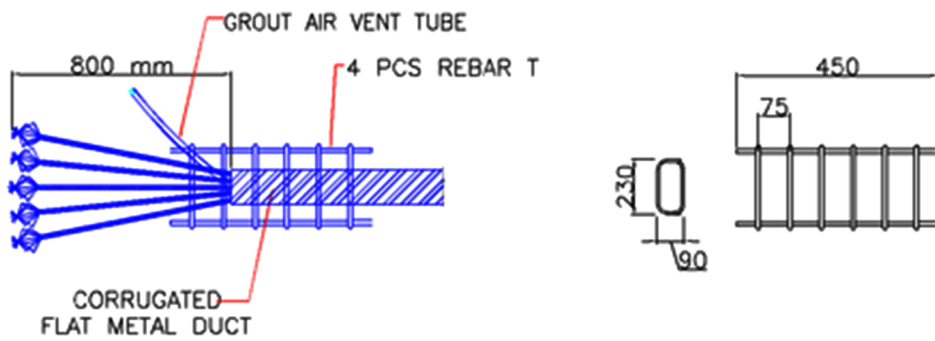
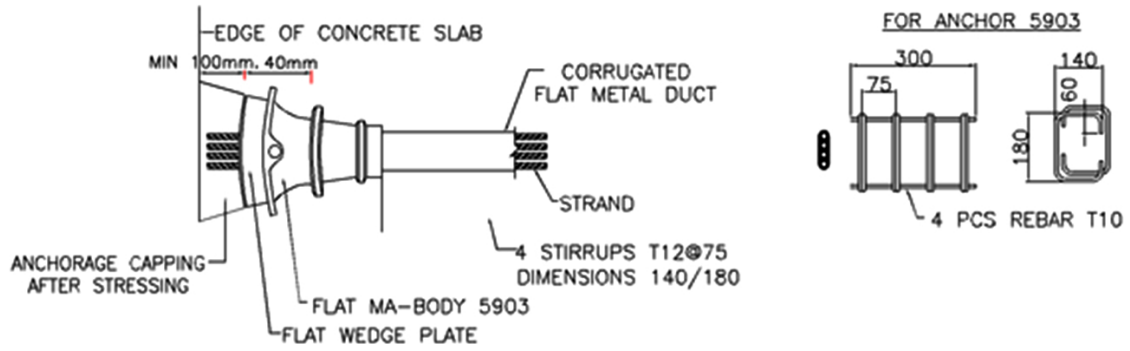
Fig. (7). Type of anchorage ends in post tension system.

a) Dead end

b) Live end

An anchor or termination point where the post-tensioning cable is anchored and cannot be further changed or tensioned is referred to as a “dead end” in a post-tensioning system. A “live end” on the other hand is an anchor or termination point where the cable can still be tensioned or modified after installation. The details of the dead and live ends are shown in Fig. (7). The dead end is often made out of an anchor block or wedge that holds the post-tensioning cable in place. A specific tool is used to wedge the cable tightly in place once it has been threaded through the anchor block. When a cable becomes wedged, it cannot be tensioned further and is considered a fixed point. The live end, on the other hand, is made up of an anchor block or wedge that is used to tension and adjust the post-tensioning cable. This is usually accomplished by using a hydraulic jack that can apply a tension force to the cable, pushing it tighter and increasing the tension. In addition to the anchor block or wedge, both dead and live ends may include other components such as ducts or sheathing to protect the post-tensioning cable from corrosion or damage, as well as grout or other materials to ensure a secure and stable anchorage.

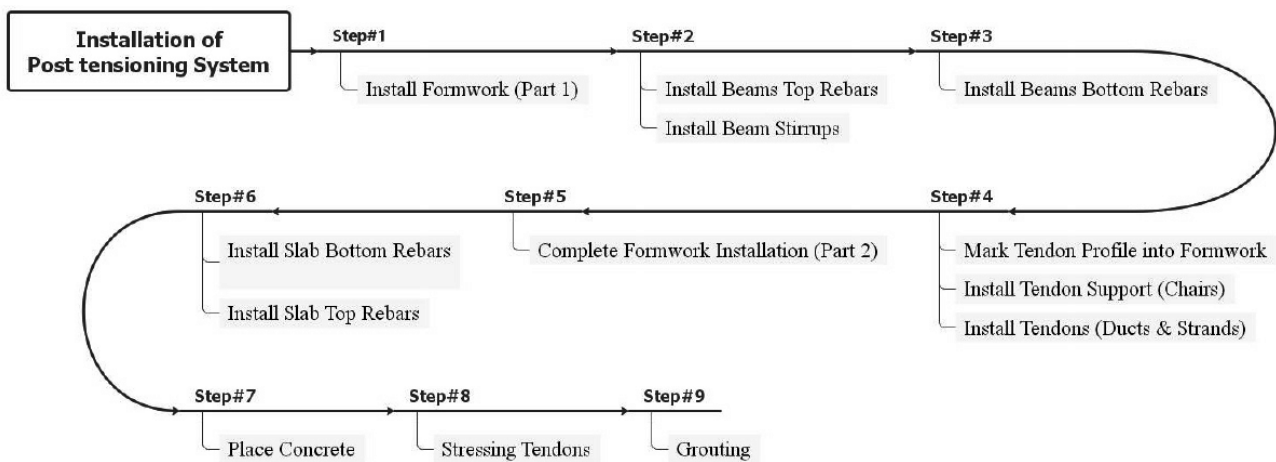
Fig. (8). Sequence of installing post tension system.

The sequence of installing post-tension system in the hall

roof is summarized in Fig. (8). The anchorage positions were marked out on the shutters of the beam side from shop drawings, then the tendon line, and chair positions were marked on the beam soffit, then the shutter was drilled and cut to accommodate the anchorage fixing bolts and strand protrusions.

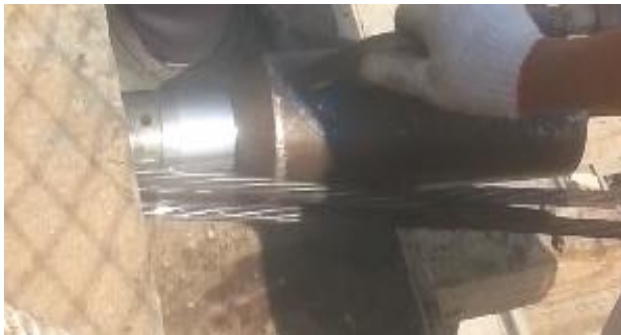
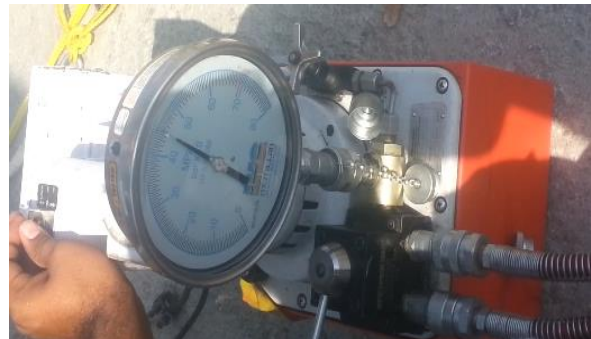
Fig. (11a, b). Hydraulic stressing jack and pump.

capacity of 300 kN as shown in Fig. (11a). A hydraulic pump with a capacity of 80 MPa was used to provide the pressure for the jack as illustrated in Fig. (11b). Each strand was locked off after stressing and the new protruding length was recorded. If the extension length which the difference between the initial and final extruding length is within limits, the strands were cut.

a) Hydraulic stressing jack

b) Hydraulic pump

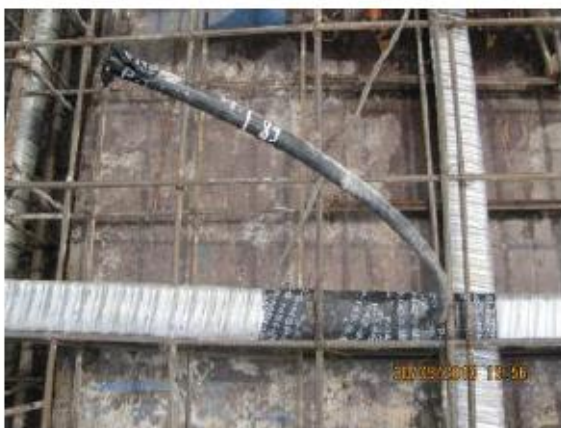
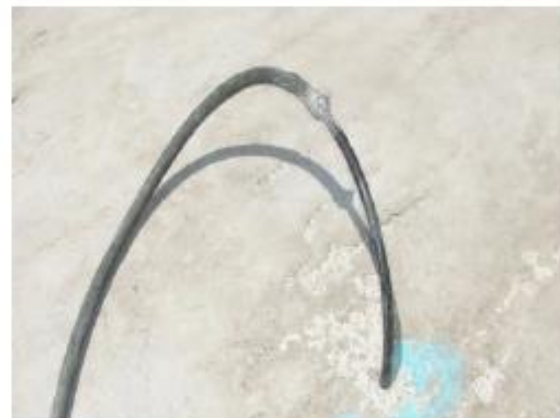
Fig. (12a, b). Grouting process.

Sika grout was used as grouting material. The grout mix proportions are shown in Table 4. Sika Intraplast Z-HV was used in the mix as an admixture for reducing the bleeding and delaying the setting time. Sikament NN was used as water reducer agent (superplastizer). Many holes were drilled/cut through the top surface of the duct, then plastic vent tubes were inserted in the holes for the passage of the grout through the duct. The plastic vents were fixed by tie and sealed using tape as shown in Fig. (12a).The vent tubes should be extended

c) Tying the vent tube with duct

d) Connecting the grout injection to grout inlet

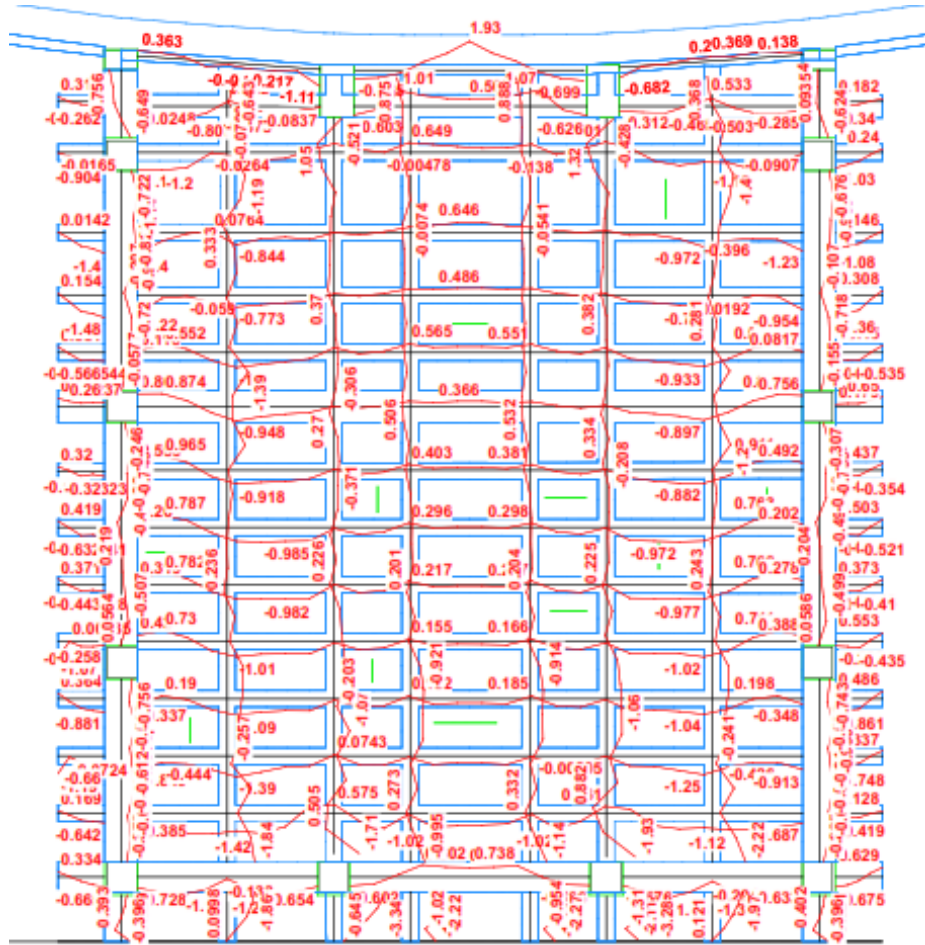
Fig. (13a, b). Top and bottom stresses in PT system (Service load: DL+LL).

stresses caused by service loads, and the slab is designed to distribute the loads and stresses efficiently across its cross-section. The amplitude and distribution of top and bottom stresses as a result of service loads are shown in Fig. (13a, b). These stresses are affected by a number of parameters, including the type and intensity of the loads, the placement and spacing of the post-tensioning tendons, and the stiffness and strength of the slab. The limits of compressive and tensile stresses are obtained by the two equations below [29]:

a) Top stress plan :DL+LL

b) Bottom stress plan :DL+LL

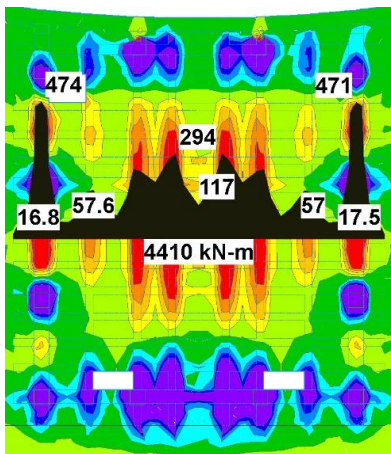
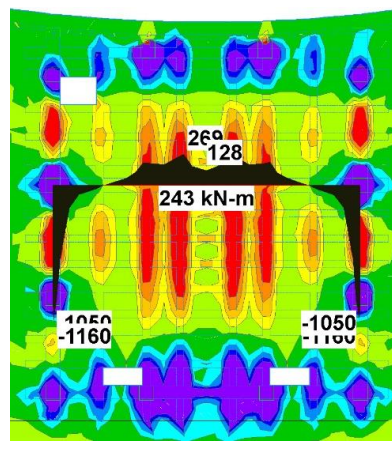
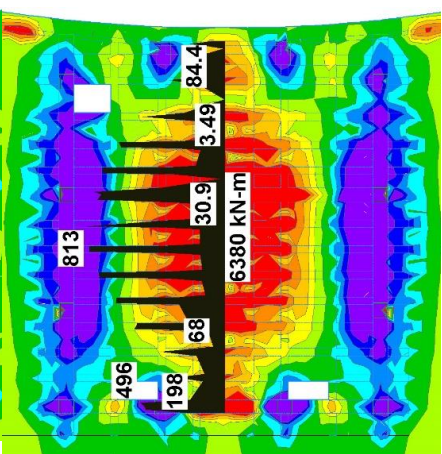
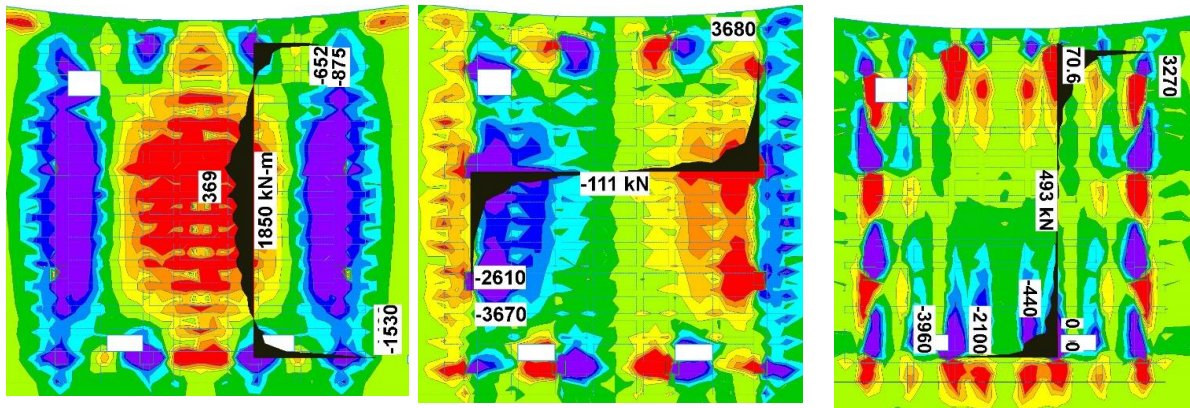
Fig. (14a-f). Contours of bending moment and shear forces (Combination load:1.2DL+1.6LL).

The results of the maximum bending moment and shear forces due to combination load (1.2DL+1.6 LL) are shown in Fig. (14). The bending moment distribution tool in Ram Concept software was used to plot the bending moment about the axis of the specified line. The integrated moment indicated beneath the moment distribution plot (e.g., 4410 kN.m in Fig. 14a) represents the whole area of the plot but does not reflect the bending moment value. The beam located in the middle of the post-tension roof in the x direction has a maximum positive moment of approximately 474 kN.m as shown in Fig. (14a),

while the beam along axis c (Fig. 3) has a maximum negative moment of 1160 kN.m, as shown in Fig. (14b). The beam that is positioned in the middle of the post-tension roof in the y direction has a maximum positive moment of approximately 813 kN.m (Fig. 14c), while the beam that is positioned along axis 4 (Fig. 3) has a maximum negative moment of 1530 kN.m as shown in (Fig. 14d). The greater values of shear forces are located at the circumferential beams of post-tensioned roof (Fig. 14e and 14e). The beam along axis c has a maximum shear force of 3680 kN (Fig. 14f) whereas the beam along axis 4 has a maximum shear value of 3960 kN (Fig. 14f).

a) Max. positive Bending moment
(Mx plan) :1.2DL+1.6LL

b) Max. negative Bending moment
(Mx plan) :1.2DL+1.6LL

c) Max. positive Bending moment
(My plan) :1.2DL+1.6LL

d) Max. negative Bending moment (My plan) :1.2DL+1.6LL
 e) Max. shear (Mx plan) :1.2DL+1.6LL
 f) Max. shear (My plan): 1.2DL+1.6LL

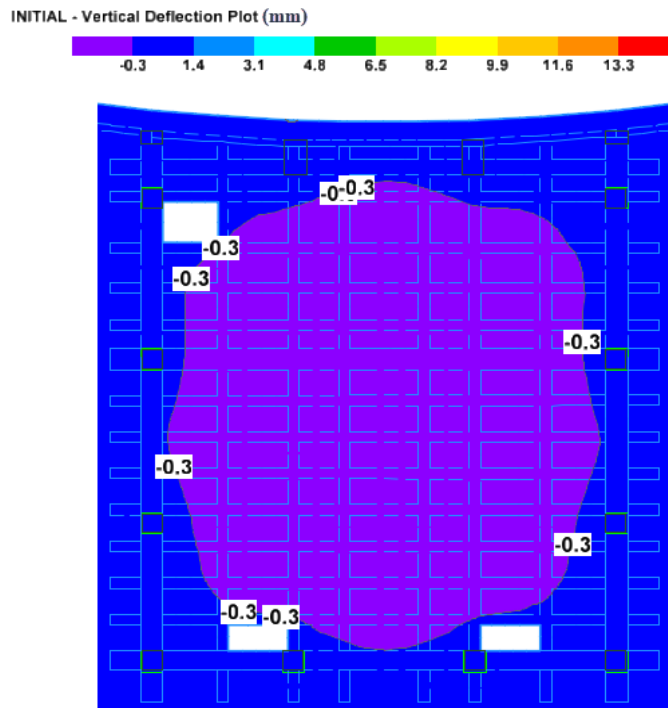
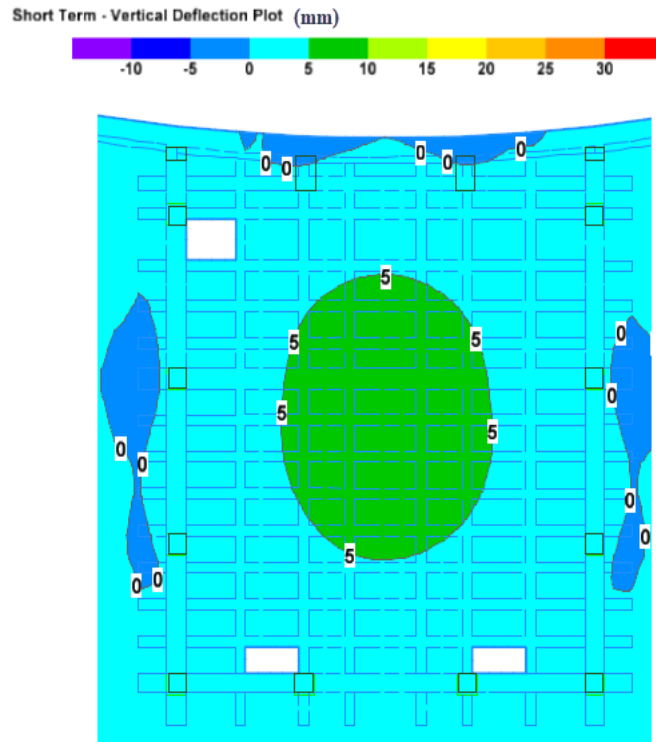
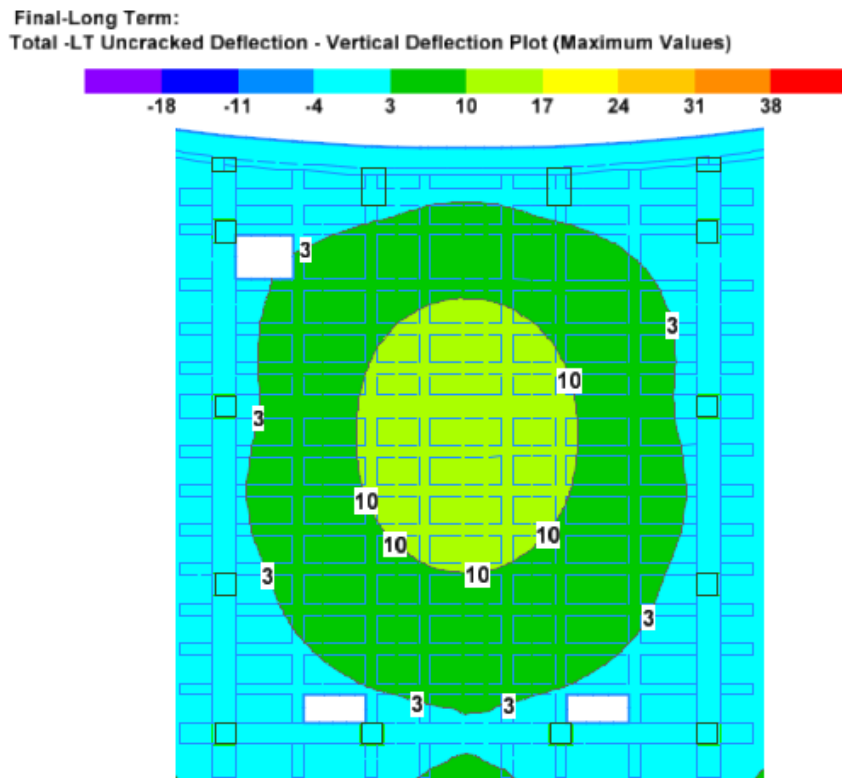
Fig. (15a-c). Initial, short and long-term deflections in the post-tensioned slab.

if it takes place in a short time [30]. Fig. (15) depicts the analysis results for the deflection occurring in the PT slabs for initial, short, and long term. The maximum upward deflection due to post-tensioning forces was 0.3 mm (Fig. 15a) and the maximum downward short and long-term deflection was 5mm (Fig. 15b) and 10mm (Fig. 15c) respectively. The short and long deflection is less than the limits (L/360 (69.44mm) and L/240 (10.41 mm) provided by ACI-318. The most significant advantages of PT systems over traditional reinforcement structures are longer spans and low deflection.

a) Initial deflection

- The maximum deflection values for initial, short-term, and long-term conditions were determined by Ram Concept software as -0.3mm, 5mm, and 10mm, respectively. These values were found to be below the permissible limits.

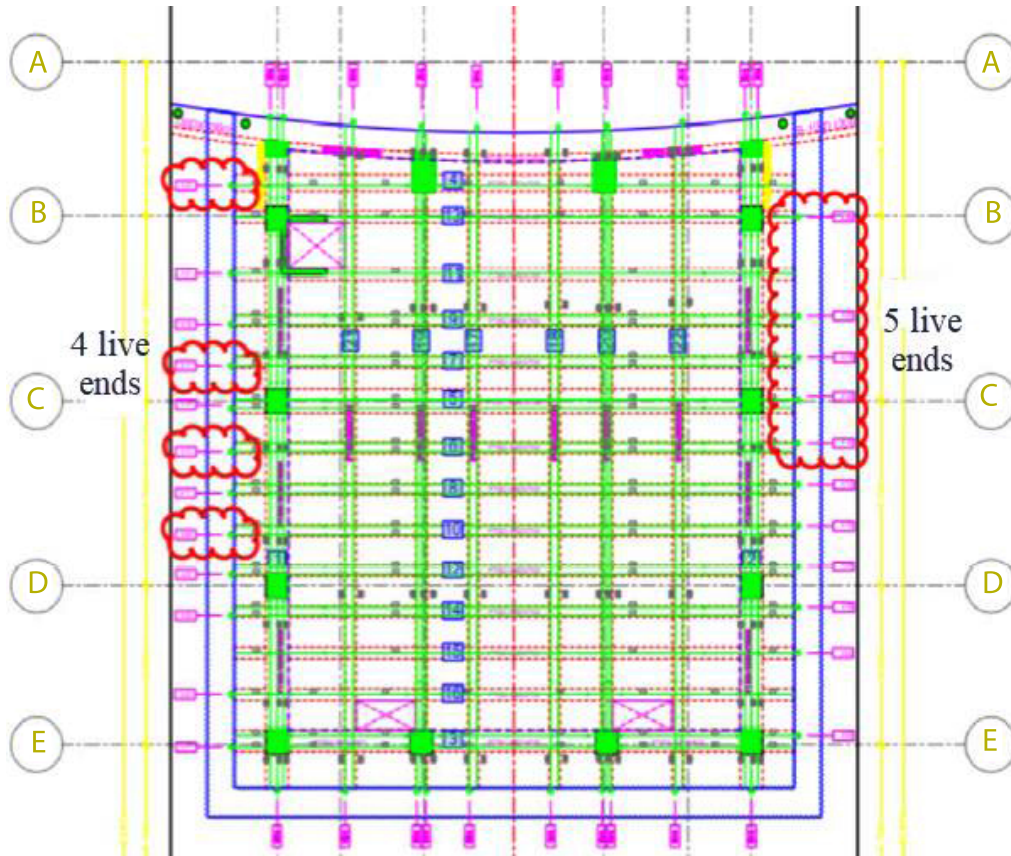
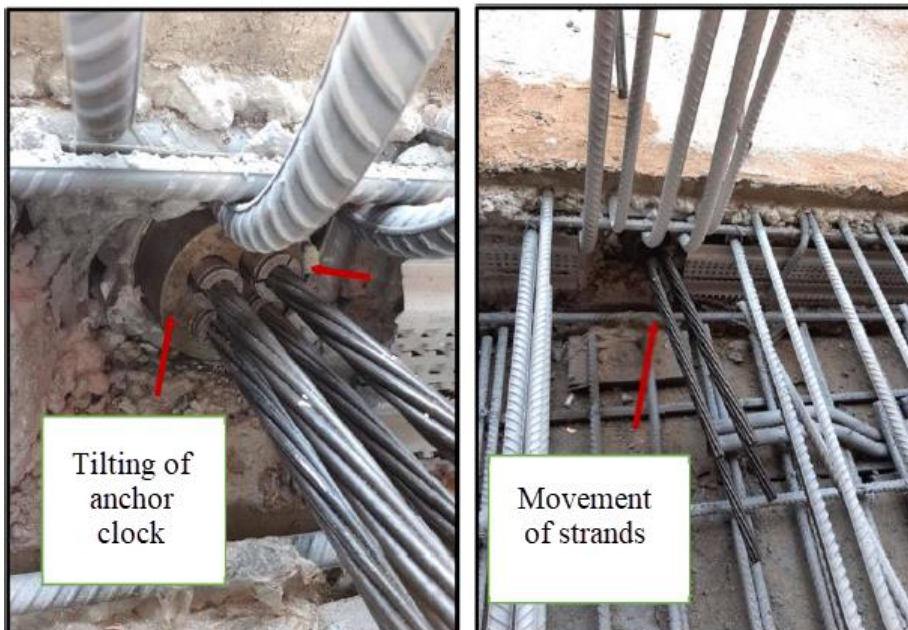
Fig. (17). Locations of live ends which have post-tension problems.

The visual inspection reveals that the anchor block tilting problem may be caused by insufficient vibration of the concrete during casting, resulting in unconsolidated concrete at the live ends. Congested steel reinforcement at the live ends, combined with insufficient vibration, results in concrete segregation. The repair plan was proposed to overcome the problem of anchor blocks tilting at the nine liv ends. The post-tension at the tilted anchor blocks was released and the strands

- During the process of post-tensioning the strands, it was noted that a total of five anchor blocks on the east side and four on the west side exhibited skewing from their initial positions. Consequently, this led to the displacement of the strands at these respective live ends.

returned back to their original status. The concrete at the live ends which has a problem was broken up with the air compressor. A new set of anchor, bearing, and wedges were installed to replace the existing post-tension system. Then, the concrete surface was cleaned and steel reinforcement was painted with rich zinc material. The zinc-rich paint is a type of coating that contains a high concentration of 65-95% metallic zinc in dry film, which provides corrosion protection to steel surfaces. The broken-up concrete was replaced by high-workable concrete (Rendorec LAXtra) which is suitable for mass infill to structural repairs in all types of load-bearing situation and usually used in regions with congested steel reinforcement. 3.38 liters of Water were used for mixing 25 kg of Rendorec LAXtra. The compressive strength of Rendorec LAXtra is about 40 MPa at 7 days and 60 MPa at 28 days. Fig. (18a - d) shows the steps of the repairing process. The post-tension was conducted after 7 days from casting. The friction between strands and ducts was reduced by using a straight emulsifiable oil. The appearance and color of the oil are shown

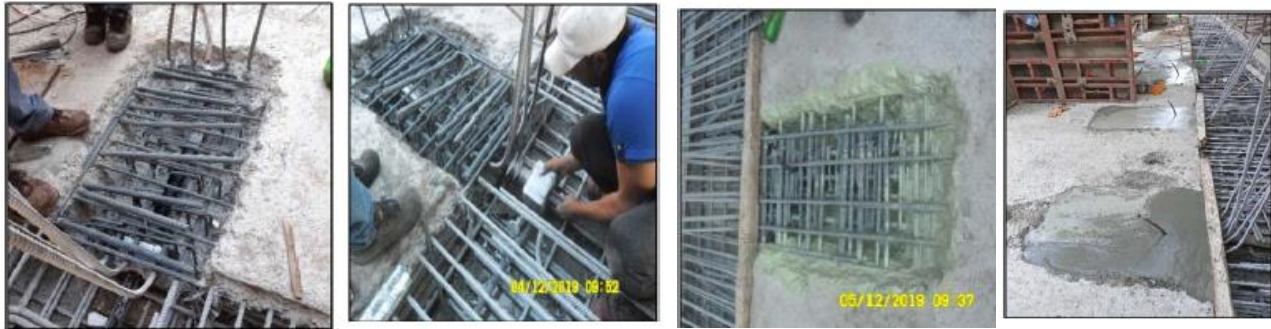
Fig. (18). Repairing 8 process.

a) Breaking up concrete b) Replacing Post-tension System c) Cleaning and painting steel reinforcement with rich Zinc d) Casting with Rendorec LAXtra material

- The repair plan was developed to resolve the problem of anchor blocks tilting at the nine live ends. The strands were returned to their original position by releasing the post-tensioning forces. The concrete at the live ends that had a problem was broken apart with an air compressor. The old post-tension system (anchor, bearing, and wedges) was

replaced by a new one. The concrete was then cleaned, and the steel reinforcement was sprayed with a zinc-rich paint. High workable concrete (Rendorec LAXtra) was used to replace the broken-up concrete.

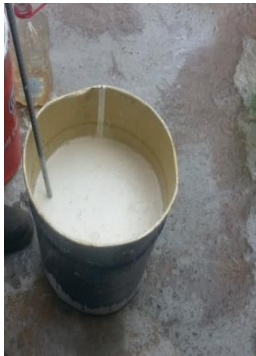
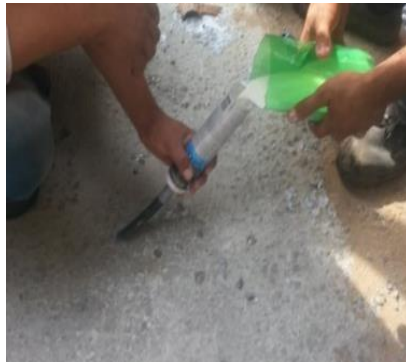
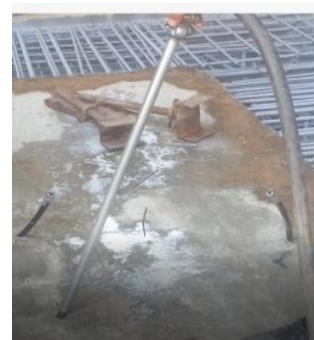
Fig. (19a-c). Process of reducing the friction between strands and ducts.

a) Friction reduced oil

b) Injection of oil

c) Applying pressure to move oil along duct

in Fig. (19a). The emulsifiable oils are commonly used in post-tensioned construction to reduce friction losses between the tendons and the ducts, thereby enhancing the transmission of post-tension forces and decreasing the likelihood of tendon

rupture or failure. The oil was injected into the plastic vent tube as shown in Fig. (19b) and then, the pressure was applied to move the oil along the entire length of strands or ducts (Fig. 19c).
