The Investigation of Stability on Slopes Utilizing Reinforcement Gabion Walls and Concrete Piles for Mitigating Landslide Disasters

Banta Chairullah¹, Munira Sungkar¹, Reza Pahlevi Munirwan^{1,*}, Khaizal Jamaluddin¹, Ferda Febrian Ramadhani¹ and Ramadhansyah Putra Jaya²

Abstract:

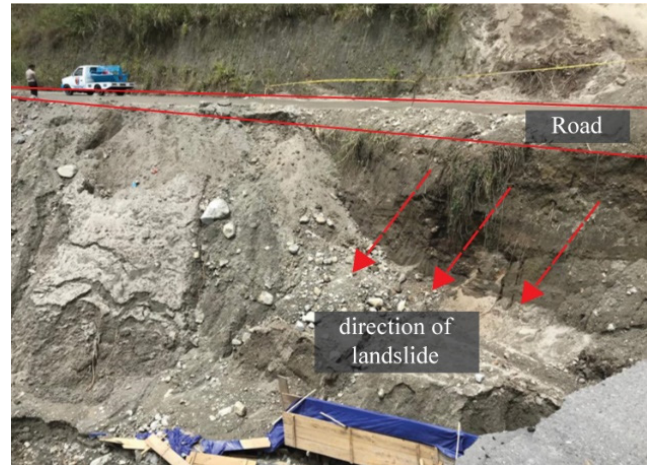
Fig. (1). The Bireuen-Takengon cross-road segment's experience of a landslide disaster, resulting in the collapse of a major section of the road.

The road routes connecting cities within the Aceh Province region, particularly in the Central-West-South area, typically traverse mountainous and uneven terrain, including mountains that are susceptible to landslides. The presence of hills and heavy rainfall during specific periods, such as November to February, create topographic circumstances that make various areas susceptible to landslides. An instance of landslides, among various other problems, occurred on the Bireuen-Takengon cross-road segment. This event resulted in the collapse of nearly the whole road, as depicted in Fig. (1). Due to this catastrophe, the transportation route from Bireuen to Takengon, namely at Km 85 in Jamur Ujung Village, Wih Pesam District, Bener Meriah Regency, has entirely collapsed. The disaster has also caused disruptions in the distribution of essential community necessities along the Bireun-Bener Meriah-Takengon route in both directions.

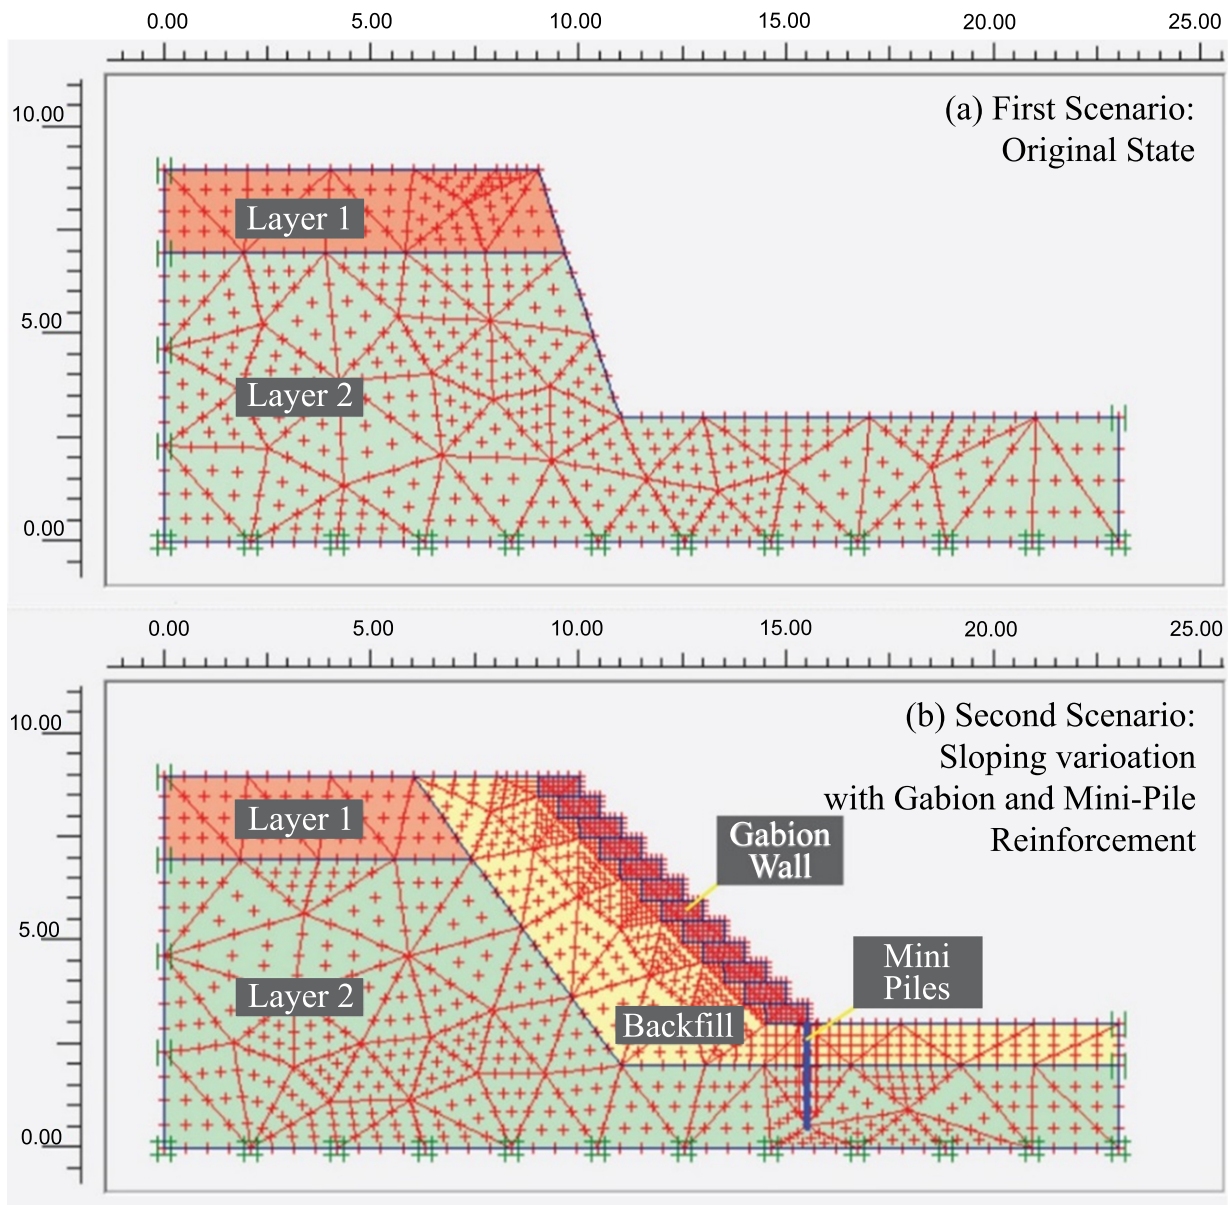
Fig. (2). Scenarios of gabion wall and minipile design for slope reinforcement.

Additionally, the study examined slope stability reinforcement through the analysis of three scenarios: without the use of retaining walls, with the use of retaining gabion walls, and with the use of gabion walls in combination with concrete minipiles. The construction of gabion walls with a combination of concrete minipiles was planned based on the considerations specified in Table 2. Before determining the proper position of the gabion walls for soil retention, it is essential to evaluate the extent of the landslide area on the slope. The location of the soil-retaining gabion wall, in conjunction with the positioning of concrete minipiles, may affect the Safety Factor (SF) of the slope. If the SF satisfies the minimum criteria, the option of utilizing a soil-retaining gabion wall combined with minipiles becomes feasible for installation. If multiple positions fulfill the slope stability safety factor requirements, the placement that is most efficient and cost-effective is preferred.

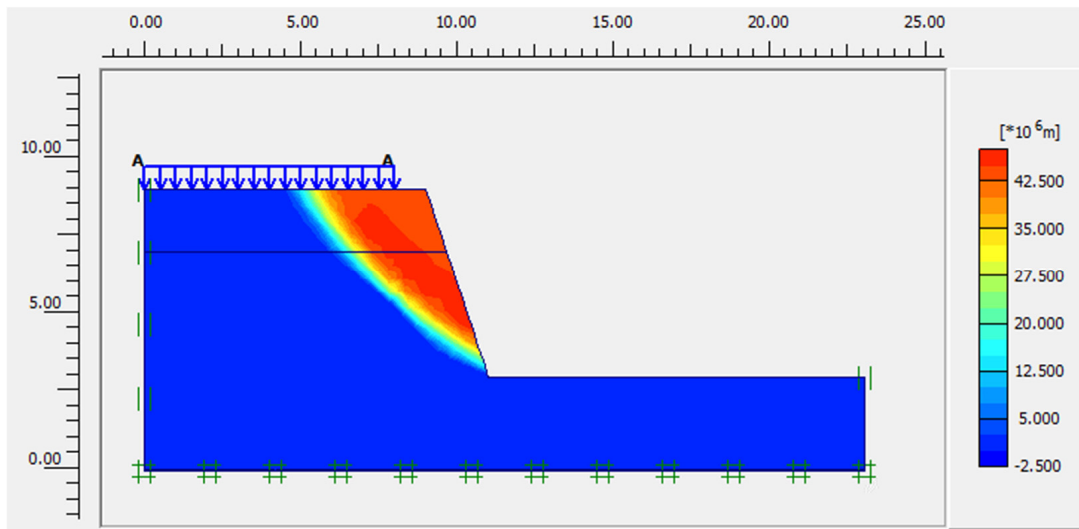
Fig. (3). Unreinforced slope results from the plaxis analysis.

Field observations from several viewpoints indicated the landslide to be of the rotating type, characterized by the movement of soil and rock masses along a concave-shaped sliding plane. The research input from the Plaxis analysis, depicted in Fig. (3), revealed the geometry of the landslide area to closely resemble the patterns observed in the field. Based on the results, the SF for an unreinforced slope was 1.11, indicating an unstable slope. Furthermore, Fig. (4) displays the results of the Plaxis analysis, specifically the slope with reinforcement of gabions and concrete minipiles.

Table 3 displays the quantitative effects of the gabion arrangement as well as the combined effect of gabions with concrete minipiles on the slope safety factor. The computation of the slope safety factor revealed the SF in the no-reinforcement state to be $SF = 1.11$, indicating landslide events aligning with the actual conditions on the site. Furthermore, the slope model with reinforcement yielded SF calculation results that all exceeded 1.5, indicating stable slope conditions. This condition was present on slopes that had reinforcement at all angles, except for slopes with a 90-degree angle when the SF was less than 1.5.

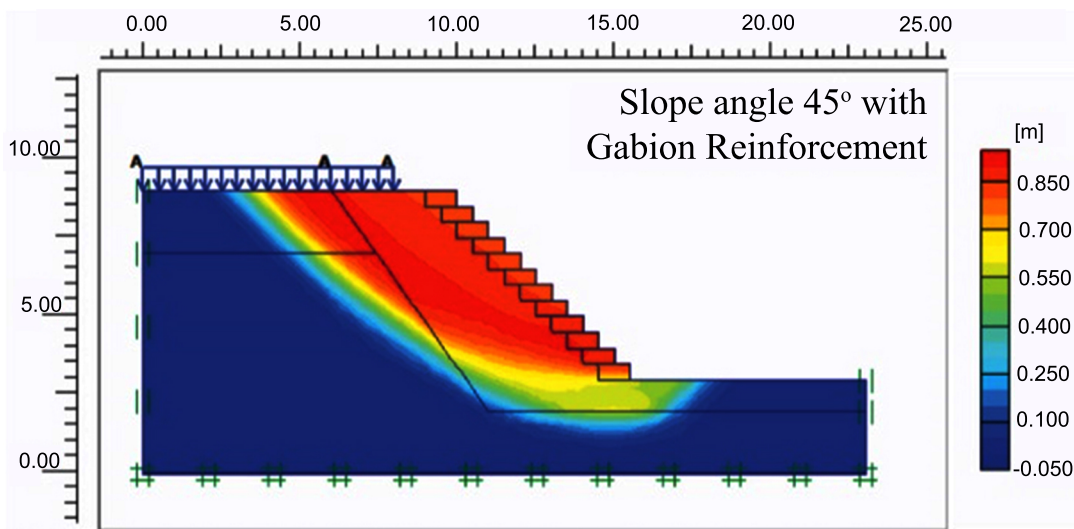
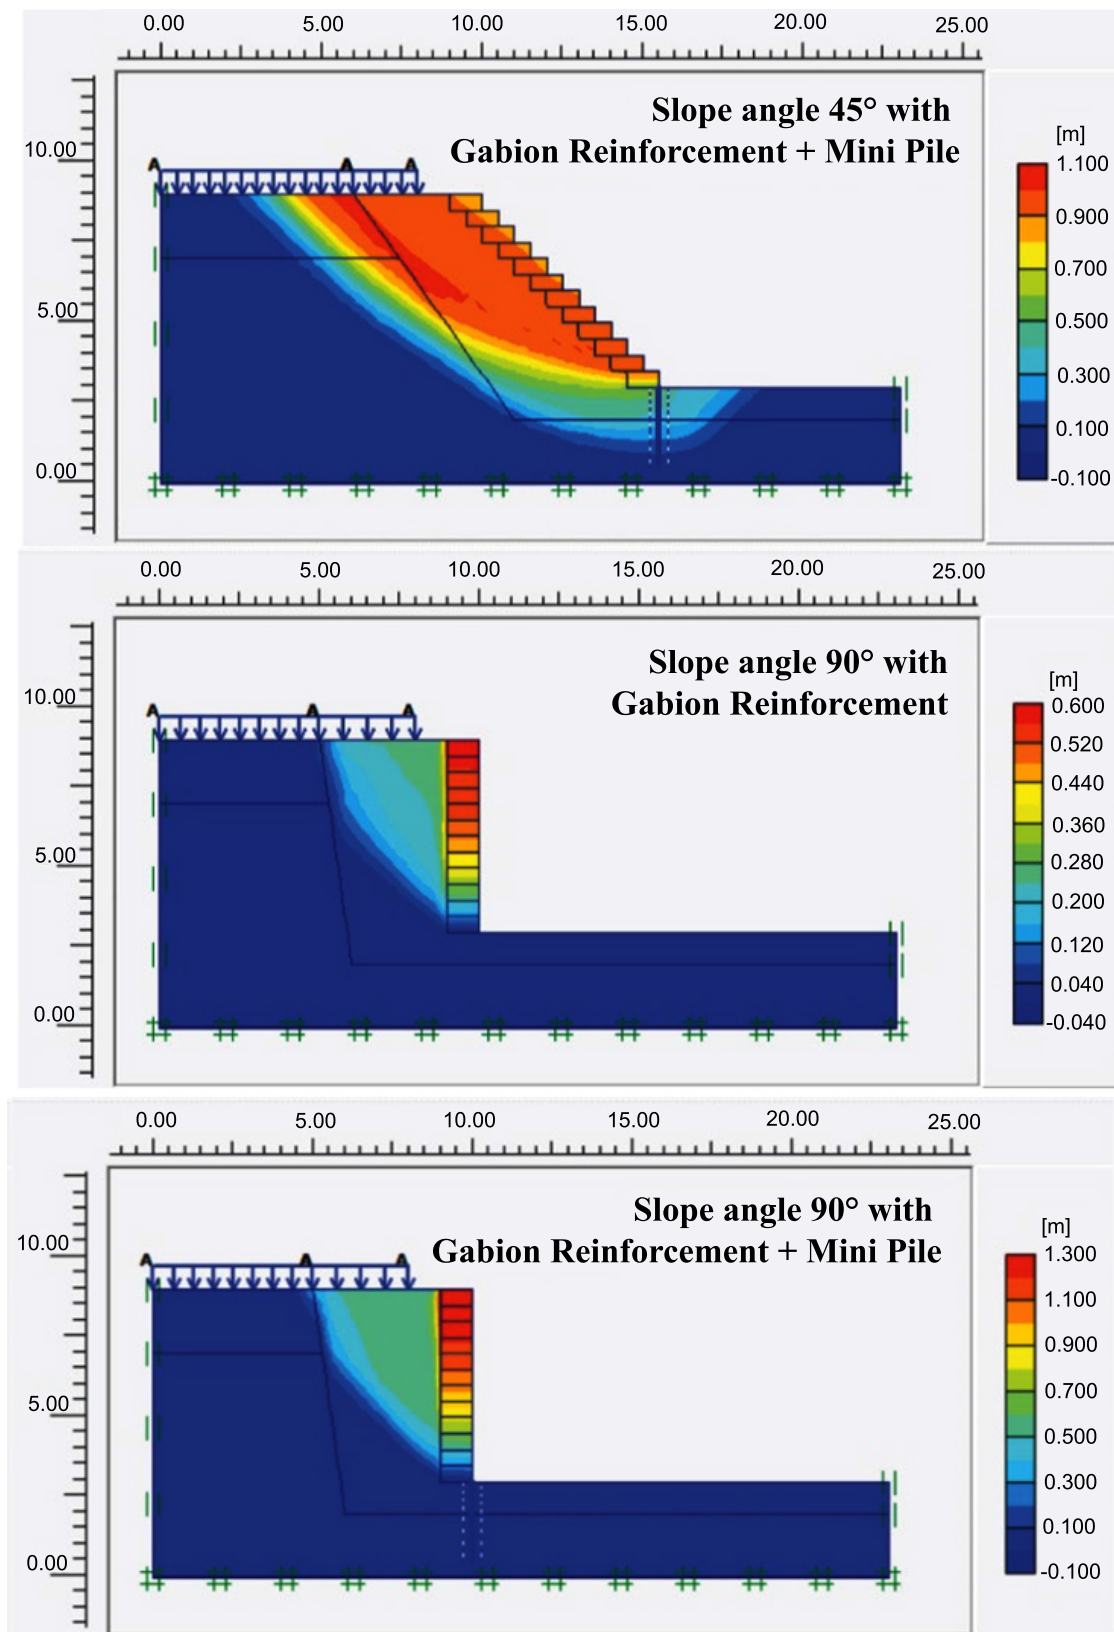
Fig. 6 contd.....

Fig. (4). Slope results with reinforcement of gabions and concrete minipiles from the plaxis analysis.

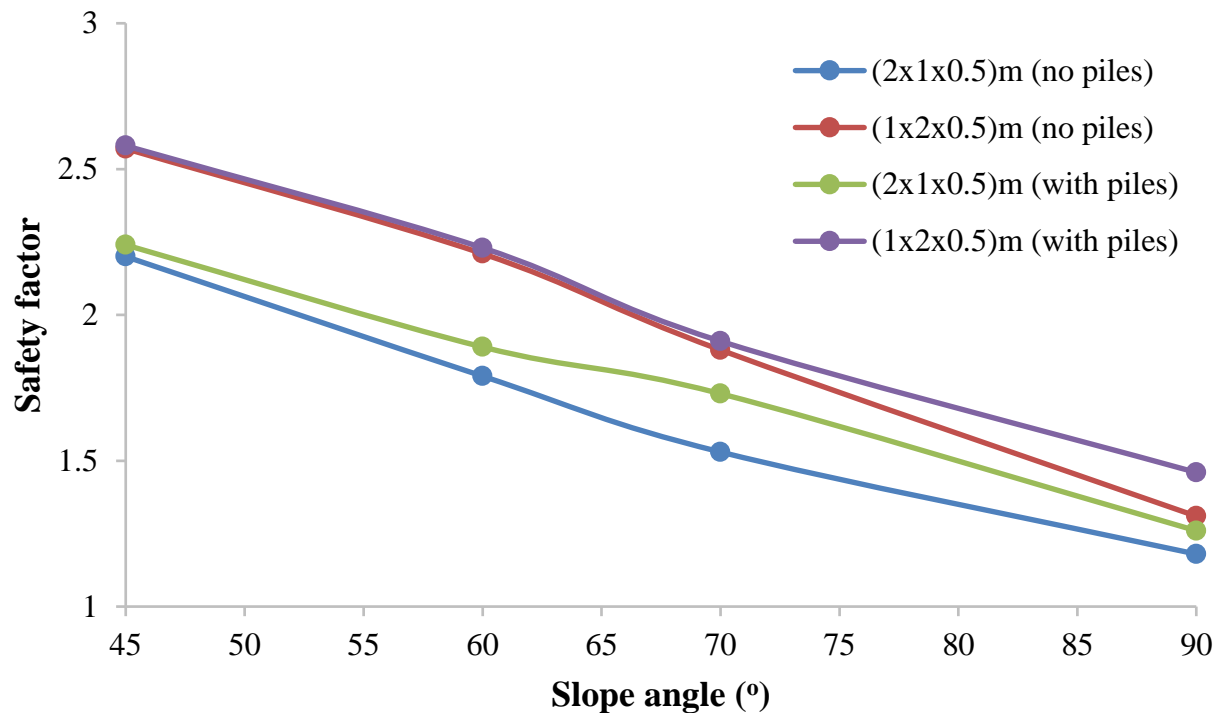
**Fig. (5).** Relationship among the gabion, minipiles, and the safety factor.

Fig. (5) plots the findings of the analysis related to the effects of concrete minipiles on the combination model incorporating gabions. The results indicated that the utilization of minipiles affected the safety factor of the slope. In contrast to the strengthening model that solely employed gabions, enhancing the safety factor of the slope with concrete minipiles was possible when gabions were utilized in conjunction with minipiles. Additionally, as the angle of the slope decreased, the safety factor increased, specifically $SF > 1.5$. Conversely, an increase in slope angle resulted in a corresponding reduction in the slope's safety factor ($SF < 1.5$), indicating the slope to no longer be secure even at a 90-degree angle.

In addition, as presented in Fig. (5), the study determined the influence of the slope angle on the slope safety factor. A decrease in the slope angle led to an increase in the safety factor. Conversely, when the slope angle increased, the safety factor decreased. At a slope angle of 90 degrees, the slope safety factor was less than

1.5, indicating the slope to no longer be safe. Additionally, combining gabions with concrete minipiles could enhance the safety factor of the slope above the strengthening procedure that only relied on gabions. The analytical results indicated that the gabion arrangement with dimensions of L-W-H (1x2x0.5) m presented a higher safety factor in comparison to the L-W-H (2x1x0.5) m model. This demonstrated that a gabion with a wider width was capable of withstanding larger external forces. Horizontal (lateral) force is one of the movements that occur in landslides. Hence, by increasing the width (W dimension) of the gabion, the length of the shear plane between the gabion's base and the ground may also grow. Consequently, the shear force that opposes the lateral movement would be greater, thus enhancing the slope safety factor. Based on the assessment results of an increase in slope SF, it can be inferred that the variables of the L-W-H gabion arrangement model had a greater influence on enhancing SF compared to the influence of

the minipile combination model. The effect of the gabion arrangement resulted in a significant increase in the safety factor, compared to the improvement obtained with the combination of concrete minipiles. The analysis revealed that the gabion arrangement model variables exhibited greater effectiveness compared to the minipile combination model variables. The potential shape of the slope failure line in the analytical slope model was believed to have minimal effect on the increase of the safety factor for slope stability.
