The Open Construction & Building Technology Journal

REVIEW ARTICLE

Retrofit, Restoration and Preservation of Byzantine Monuments: Assessment of Natural Degradation and Evaluation of Intervention Options

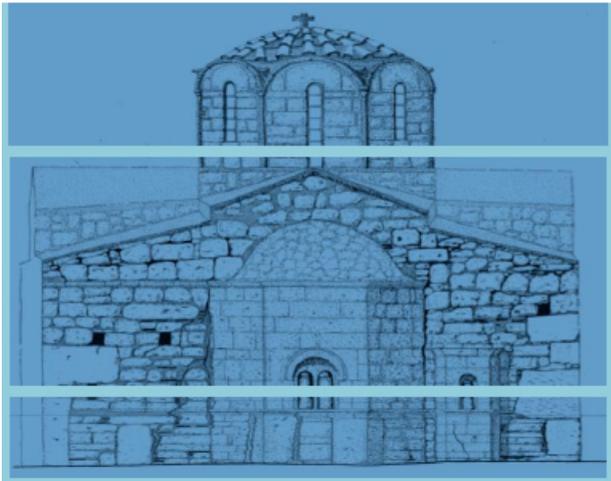
Fig. (1). Example of a byzantine stone monument with obvious signs of natural corrosion.

and seismic action), *etc.* Certainly, all the maintenance works must be a part of an optimal process of restoration of a monument (Fig. 1).

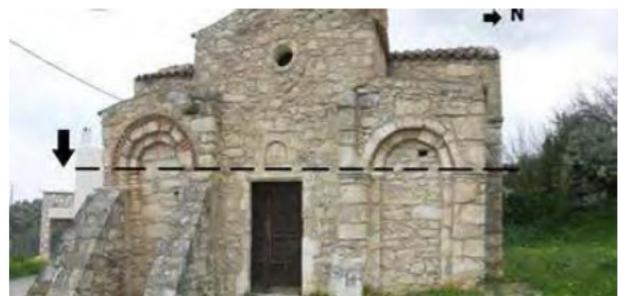
Fig. (2). An example of the effect of a combination of forces acted on a byzantine monument in Crete, of which the seismic load is the predominant force (Church of St. Demetrios near a village in the Rethymno district).

In parallel with these Regulations, in Greece, special local Regulations are used, compatible with the engineering principles contained in Eurocodes. Such a technical code is the Regulation for Evaluation and Structural Interventions in Masonry (R.E.S.I.M.), which is a detailed technical standard for interventions mainly in historical buildings with natural degradation (Fig. 2).

physicochemical and biochemical actions are continuous and may cause a gradual decrease in the strength and durability of a monument and consequently make it more vulnerable to seismic actions (Fig. 2).

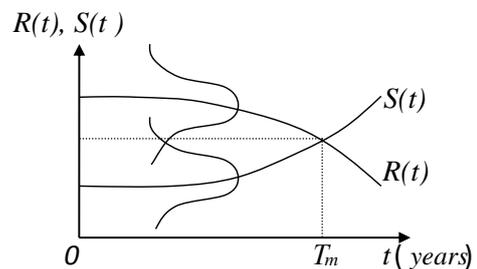
Fig. (3). Stochastic (probabilistic) graphical representation of actions/resistance in monuments.

If we now assume that both the resistance and action values satisfy, as stochastic quantities, the normal Gaussian probabilistic distribution (Fig. 3), then what we require is that the value of the probability of exceedance $P_{f,t}$, regarding the resistance $R(t)$, is less than or equal to the desired value P_{tar} ,

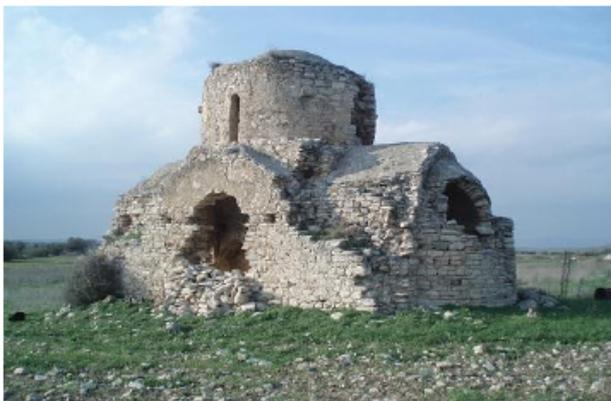
Fig. (4). Another example of the effect of a combination of forces acted on an abandoned byzantine monument in Cyprus, of which the seismic load is again the predominant force (Church of St. Marina near a village of the Larnaca district).

Moreover, by observing the collapsed parts of the walls and of the domes of a byzantine church (damage which was occurred at some time in the past due to seismic activity), we understand that it is necessary to re-install the stones which

have fallen off or replace those that have serious damages with new stones (Fig. 4). In any case, the installation of stones on the masonry is made using scaffolding. Also, bonding materials, *i.e.*, special mortars, offer high cohesion. Moreover, the installation of tendons as well as the application of reinforcing meshes (metal or polyethylene/polypropylene laths), covered by new mortar coatings (in place of those who have collapsed), are some usual methods used to increase the strength of a monument against earthquake actions [16].

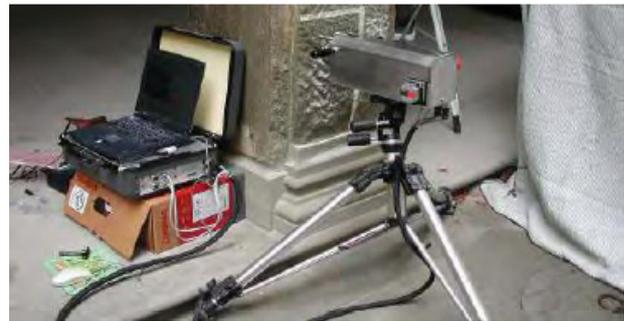
Fig. (5). Penetration force measurement method (also known as needle penetration test).

The *penetration force measurement method* (Fig. 5), also known as the *needle penetration test*, is used to check the degree of wear on the material of the load-bearing elements. This method measures the depth d at which a metal pin of standard dimensions of a special device can penetrate the material of an element.

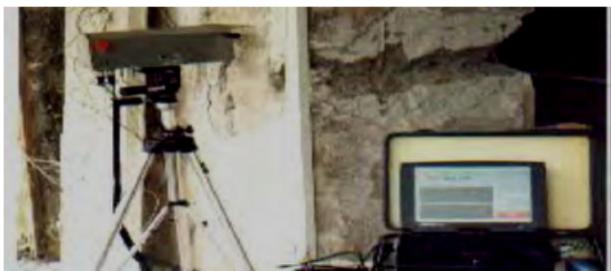
Fig. (6). Torque measurement method.

This method of measuring the torque T , known as *torque measurement method* or *torque penetrometric test*, is analogous to the previous method. Torque is applied with a special device (Fig. 6) to investigate the degree of disintegration in the material of an element of an existing structure. With this method, the angle of rotation ω of a standard metal rod inserted in the material's mass is measured. The value of angle ω , which is recorded at the failure of the material, is proportional to the torque T applied, which is also measured with the aid of a computer connected to the device. It is expressed in units of force multiplied by unit length ($N.m$). The linear relationship between the two parameters is as follows:

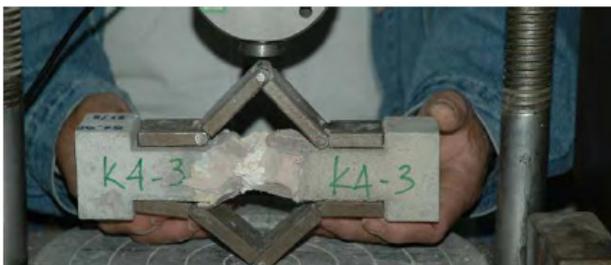
Fig. 7. Laboratory test of tensile strength in a specimen of a material taken from an existing structure.

where F_t is the tensile force acting on the active cross section A_{eff} of the laboratory specimen, imposed by a suitable device (Fig. 7). Some typical experimental results of compressive strength on samples taken from different positions of a sand-stone masonry of a monument in Cyprus (base, middle and top of the wall) are given in Table 2 (machine error= ±0.1kN):

Also, some typical experimental results of tensile strength (Fig. 7) performed on samples taken from different positions of a historical mortar, on a monument, are given in Table 3 (machine error= ±0.1 kN):

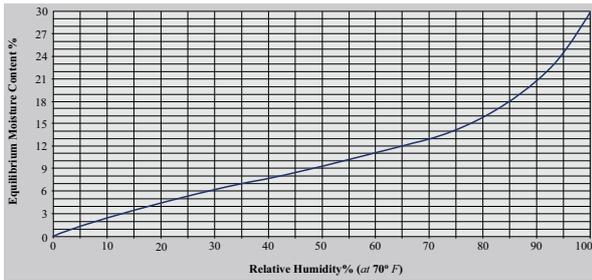
Fig. (8). Graph of percentage equilibrium moisture content in terms of relative humidity in the wood.

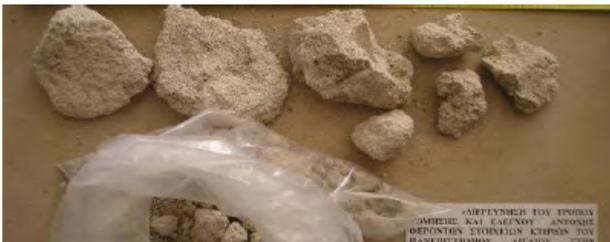
Fig. (9). Laboratory analysis for the characterization of historical mortars.

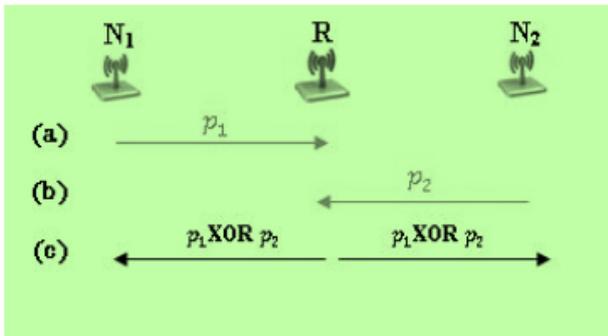
Fig. (10). Schematic representation of wireless sensor operation.

Wireless sensors [27] are a result of the advances in wireless communications, embedded computing, low-power VLSI circuits and especially in the technology of special electromechanical systems known as Micro-Electro Mechanical Systems (MEMS). This technological advancement has contributed to the development of multifunctional “smart” sensors of low cost and low power consumption, which are small in size and communicate with each other through human intervention, at short distances, as depicted in Fig. (10).

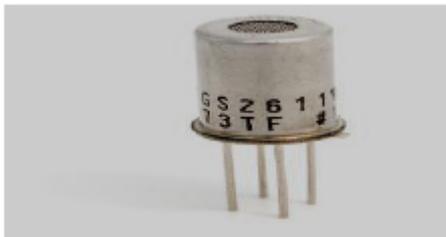
Fig. (11). Individual wireless sensor for monitoring humidity at a specific point on the monuments surface.

These tiny sensor nodes (Fig. 11), which consist of “smart” electronic circuits designed for wireless communication and data processing, have led researchers to the idea of a network of sensors based on the joint collaboration and operation of a large set of nodes (Fig. 12). The sensors send data in the form of time series to a central processing unit. These time series are of the form

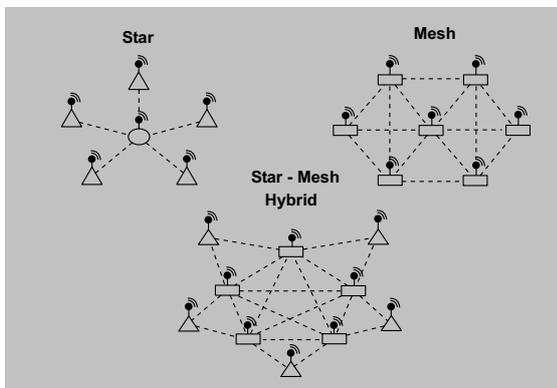
Fig. (12). Schematic representation of wireless sensor networks.

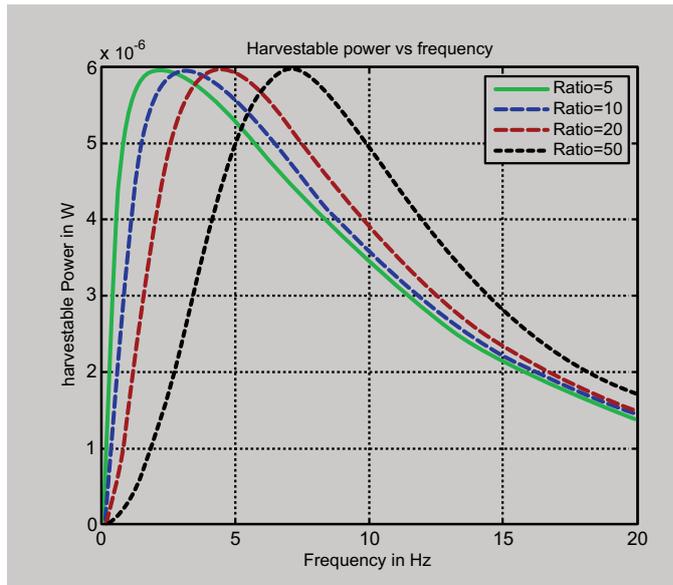
Fig. (13). Power distribution of wireless sensors in terms of signal transmission frequency.

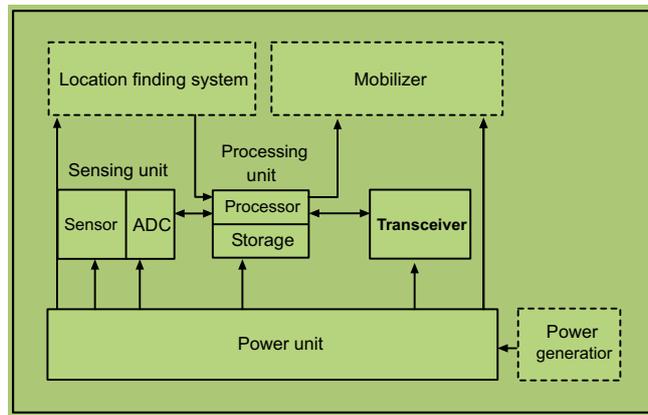
Fig. (14). Operation flow-chart of a wireless sensor.

In general, a wireless sensor node consists of the following parts: a sensing unit, a processing unit, a transceiver unit and a power unit. The operation diagram of a wireless sensor is shown in Fig. (14).

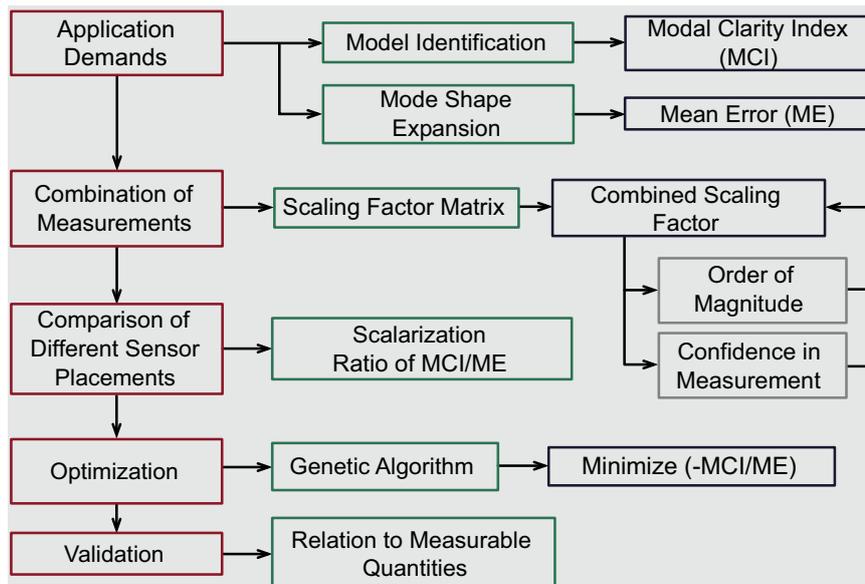
Fig. (15). Flow chart for the strategic installation of sensors.

The whole strategy of installing the most suitable wireless sensors on the surface of a monument, with the main parameters developed above, is presented in the flow chart shown in Fig. (15). The better the network design, the better the management of the received data. Thus, for example, for the measurement of humidity it is necessary to adapt the network to the measurement of the electrical resistance Z_i that presents, at different positions, the existing material of the monument, at different times t_j and temperatures $T_i(t_j)$. The statistical treatment of the values $Z_i(t_j)$ of electrical resistance and of $T_i(t_j)$, measured by wireless sensors, has resulted, in recent years, in the well-known Arrhenius time function:

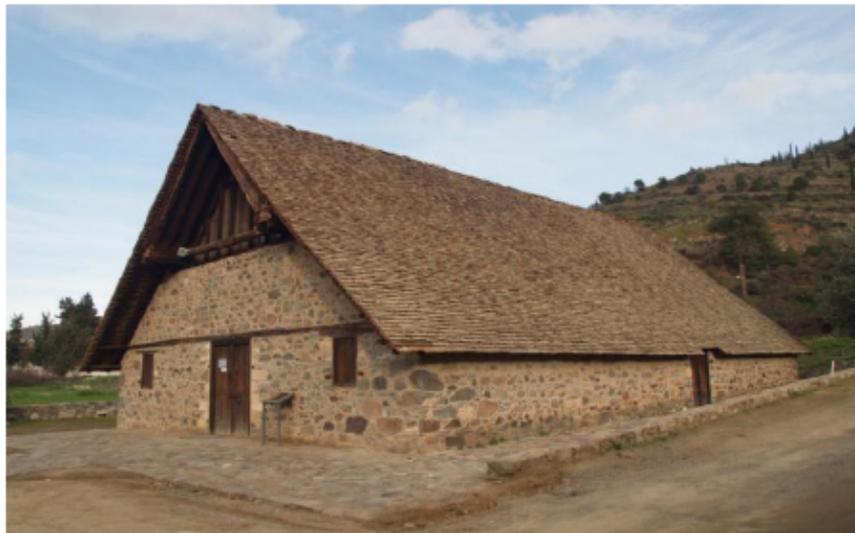
Fig. (16). Example of a retrofitted and restored Byzantine monument, of the 15th century, in Cyprus (Church of Virgin Mary near a village of Troodos mountains).

EXAMPLE: In a stone-built with wooden roof church of the 15th century, situated in the Troodos Mountains on the island of Cyprus, the following failures have been observed (Fig. 16):

- The wooden roof was displaced at some time in the past due to earthquakes. This displacement has caused local damage to the upper half of the stone masonry in the perimeter of the monument.

- Due to the uneven distribution of the soft soil under the foundation of the building, the differential settlement has taken place between the north and the south side of the building, of the order of 8 to 10 cm. Also, due to the earthquakes which took place in the past and the aforementioned soil peculiarities, the north and south walls of the church have been slightly diverted outwards.

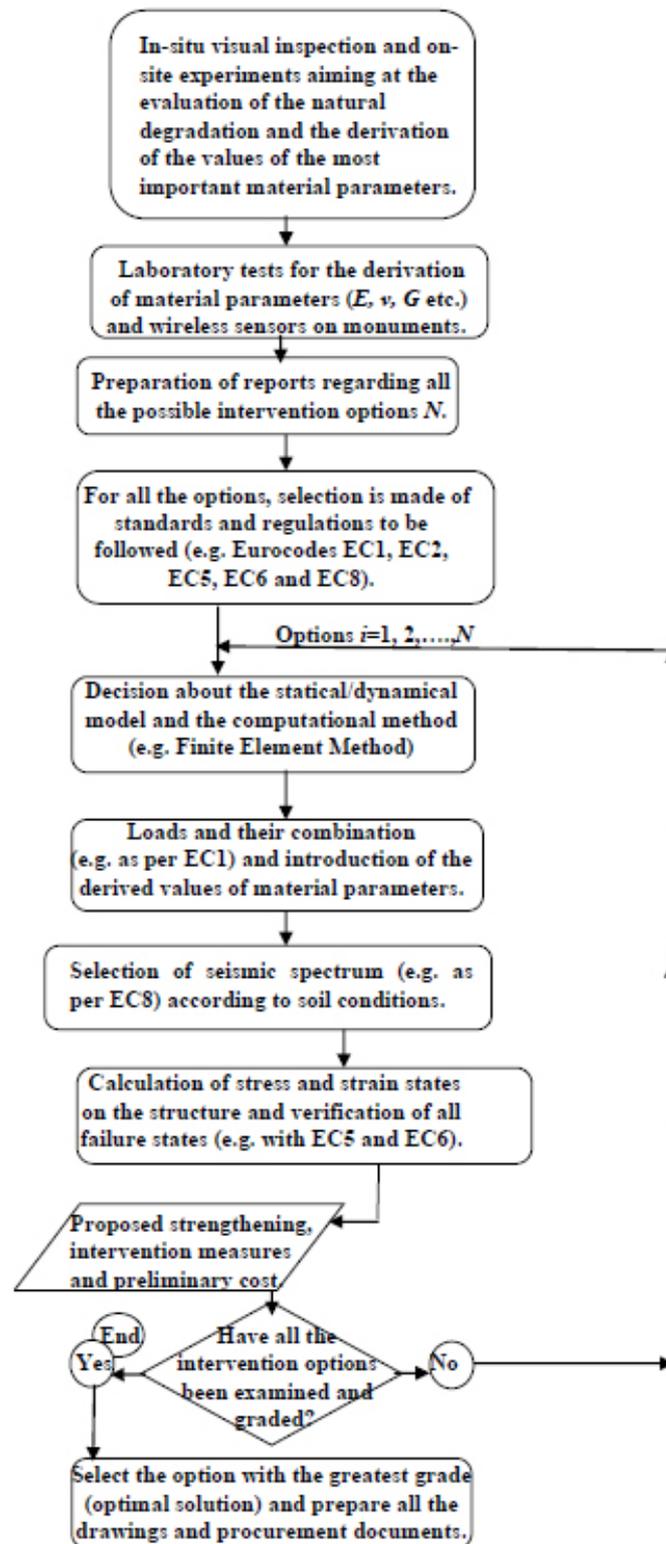
Fig. (17). Flow chart of the retrofit and restoration procedure presented in the article.
