Numerical Analysis of Historic Structural Elements Using 3D Point Cloud Data

3. CASE STUDY: THE CISTERN OF THE HAGIATHECLA BASILICA, SILIFKE, TURKEY

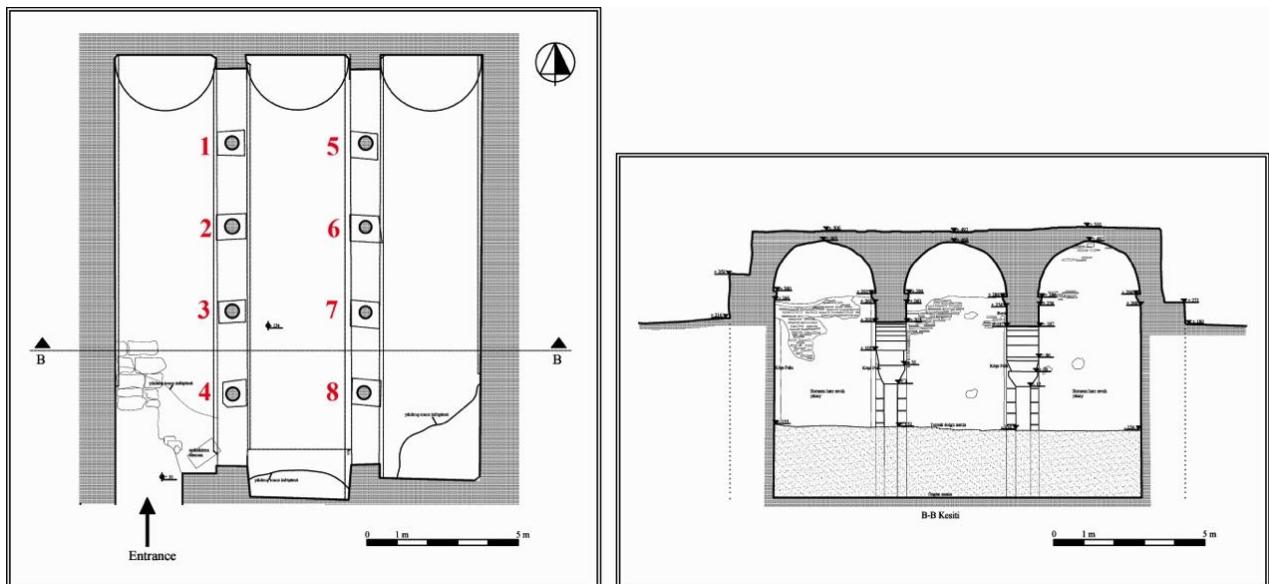
Fig. (2). The cistern of Hagia Thecla Basilica, plan and cross section [6].

The interior is divided into three aisles by two rows of columns each spaced 2.3 metres apart with the height of 3.5 metres (Fig. **2**). The columns in each row are connected by semi circular arches. Three barrel vaults, running in the north south direction, cover the interior.

The columns supporting the upper structure originally had a diameter of approximately 45 cm (Figs. **1**, **2**). They are made of a pink calcareous stone. The columns have double capitals made of limestone (Fig. **1**). It is not possible to make observations about the condition of the column bases and the floor, due to the thick layer of earth accumulated inside the cistern over centuries.

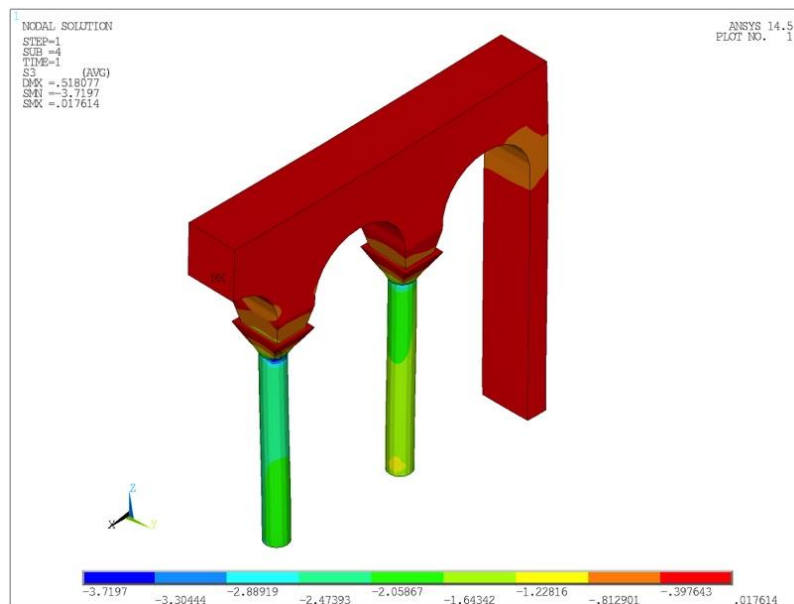
Fig. (4). S3 Principal stress distribution of the structure under its self weight.

According to the results of the linear static analysis, maximum stresses in compression (3,7 Mpa) appear on the columns (Fig. **4**). However, it should be noted that 3D model of initial geometry presents columns with a diameter of 45 cm.

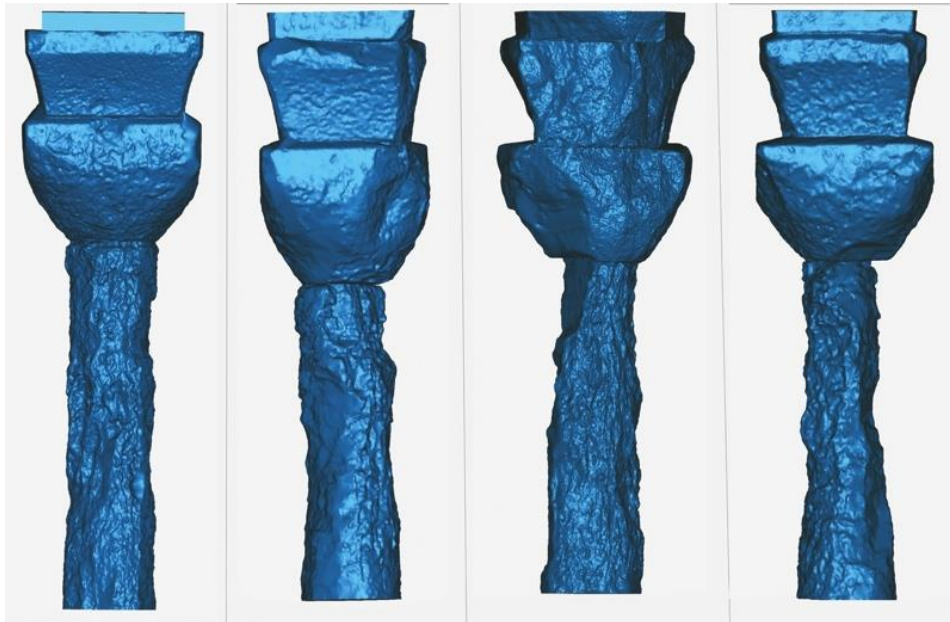
Fig. (8). Surface models of Column 1, Column 2, Column 4 and Column 7.

The most vulnerable elements of the cistern are the decayed stone columns. The cross sections of the columns have decreased remarkably (Fig. **5**). The exterior surfaces are flaking due to physicochemical effects; the erosion continues. In addition to surface erosion with a non uniform pattern, there are deep cavities on the columns (Table **1**).

Column	Damages	Min. cross section area* (cm^2)
Column 1	Non-uniform erosions.	1037
Column 2	Deep cavities and non-uniform erosions.	1231
Column 4	Severe and non-uniform erosions. Fractured and missing parts both on the columns and capitals.	800
Column 5	Relatively uniform erosions.	1355
Column 6	Relatively uniform erosions.	1181
Column 7	Severe and non-uniform erosions. Fractured and missing parts close to the connection with the capital.	827
Column 8	Severe and non-uniform erosions. Fractured and missing parts close to the connection with the capital.	1204

The restoration proposals will eventually focused on the replacement of damaged column shafts with new stone elements. At that point, some questions will rise such as "Which columns have to be intervened? Which parts of the decayed column shafts should be removed and renewed? What will be characteristics of the new stones employed for the replacements? Will any kind of consolidation work needed for the remaining original columns shaft parts while replacing some of them? To reply these questions, one of steps that should be taken in the field is to remove cautiously the accumulated debris around the columns in order to investigate the state of the material. This cleaning work will also influence the extent of repair works considering the removal renewal of damaged column shafts. If the invisible parts of the columns under the accumulated debris are relatively in good shape regarding the surface erosion and cavities, replacement program might be scheduled according to the results of this study. The decision of material, profile and finishing for the new column shaft is subject to architectural conservators and engineers responsible for the conservation works.

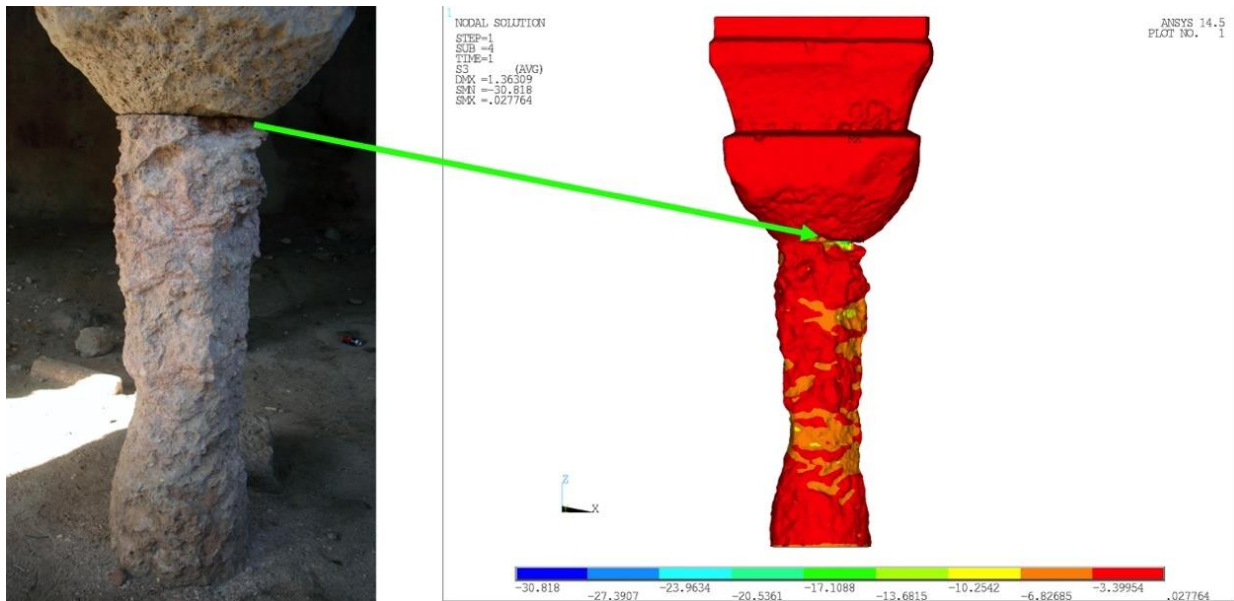
Fig. (9). Cross section of Column 7, anomalies due to non-uniform erosion.

According to the results of linear static analysis, maximum stresses in compression (Column 1: 18MPa; Column 2: 27MPa; Column 4: 26MPa; Column 5: 25MPa; Column 6, Column 7: 30MPa; Column 8: 21MPa) always appear on the zone between columns and capitals (Fig. **9**).

The change in cross sectional area, which is basically a geometric discontinuity, causes the columns to experience a local increase in the intensity of stress field. This phenomenon was also clearly seen during the analysis of the whole structure under its self weight. Correspondingly, the upper edges of columns are fractured and damaged (Fig. **9**). In

addition, observations concerning this specific zone demonstrate a limited contact surface between the two parts, which aggravates the stress distribution.

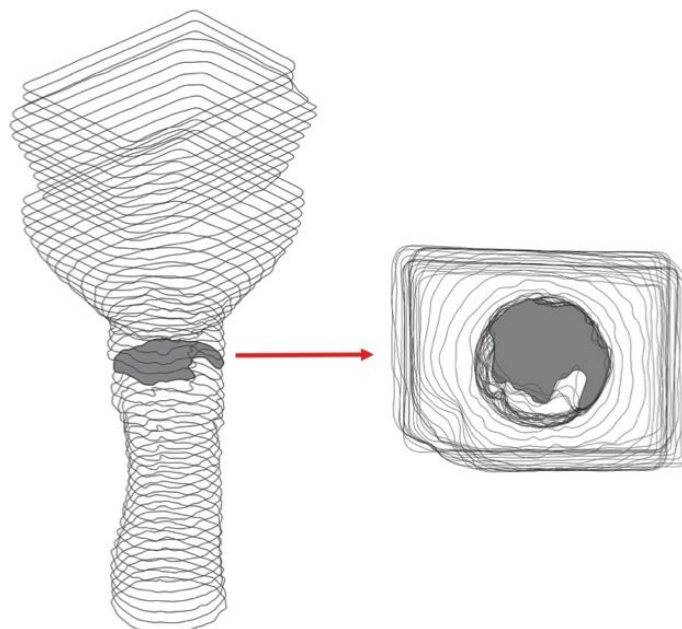
Fig. (10). Cross section of Column 2, anomalies due to non-uniform erosion.

According to results, elevated stress values were also presented on the main body of columns (Figs. **10**, **11**), where local anomalies such as severe erosions, fractures or cavities exist (Column 2: 17MPa; Column 4: MPa; Column 6: 19MPa; Column 7: 14MPa; Column 8: 18Mpa). These geometrical anomalies were successfully captured; thanks to the 3D documentation and represented in the solid models (Fig. **10**).

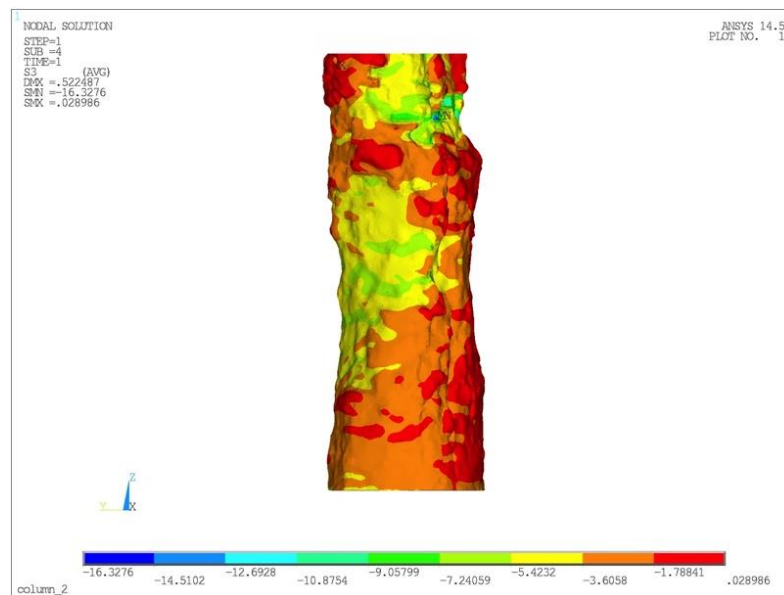
Fig. (12). Column 7, eccentricity due to non-uniform erosions, material loss and construction defects.

Further significant information revealed through 3D scanning concerning the eccentricity of loading (Fig. **12**). The effect of eccentricity is clearly evident for some of the columns in terms of stress distribution. The eccentricity derives from two sources: the non uniform erosions and construction defects, which comprise placement of both capitals

slightly away from the vertical axis of the columns.
