Typical Collapse Modes of Confined Masonry Buildings under Strong Earthquake Loads

R.K.L. Su*,[1], Y.Y. Lee[2], C.L. Lee[1] and J.C.M. Ho[1]

[1]*Department of Civil Engineering, The University of Hong Kong, Hong Kong, PRC;* [2]*Department of Building and Construction, City University of Hong Kong, Hong Kong, PRC*

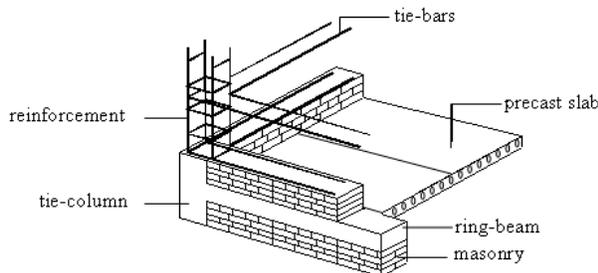
Fig. (2). Typical confined masonry buildings in Sichuan.

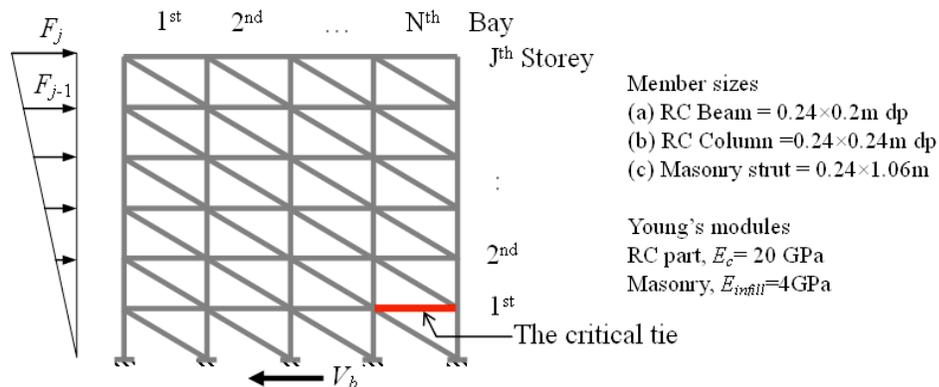
**Fig. (7).** Strut and tie model for an infilled frame building subjected to lateral earthquake loads.

By considering that the number of storeys of the building varied from two to ten (J =2 to 10) and the number of bays was either two or four ($N = 2$ or 4), a finite element analysis using the finite element package ETABS [5] was conducted. The internal forces (F_t) in the critical tie as highlighted in Fig. (**7**) were determined. The normalized tie forces ($F_t N/V_b$) are presented in Fig. (**8**). Using the regression analysis, the normalized tie force was expressed in terms of the number of storeys. The normalized tie force can be estimated by Eq. (3).

For a six-storey building with two bays only, the maximum tie force F_t can be as high as $0.51V_b$. For cast-in-situ floor slabs, the flexural reinforcement provided is often sufficient for serving as ties. However, for restraining precast floor systems, sufficient ties or tie beams have to be installed to prevent the premature tearing failure of the floor diaphragm.

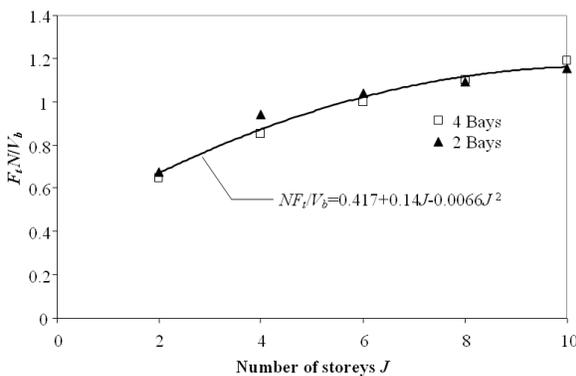
Fig. (8). Normalized tensile force in the critical tie.

$$\frac{N F_t}{V_b} = 0.417 + 0.14J - 0.0066J^2 \tag{3}$$

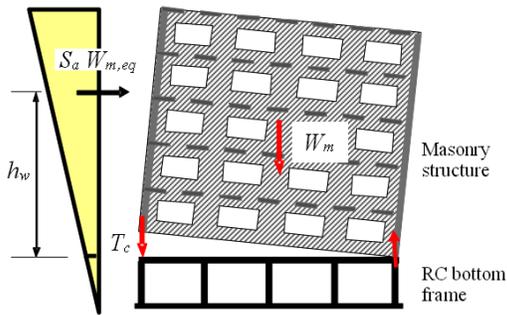
Fig. (10). Free body diagram of the masonry structure above the RC bottom frame.

The masonry building with a bottom frame, as shown in Fig. (**4**), is considered again. Knowing that the bottom rein-forced concrete frame, which is provided with more tension reinforcement, is much stronger than the masonry super-structure on top of the frame, tension failure usually occurs at the interface between the reinforced concrete frame and the confined masonry structure (i.e., at the top of the first floor). Fig. (**10**) shows a free body diagram of the masonry structure above the bottom frame. The average bearing stress developed in the load-bearing masonry walls at the first floor can be obtained from Eq. (5).

Under strong lateral earthquake loads, uplifting could oc-cur at the exterior masonry walls. Assuming that the ma-sonry body deforms rigidly, when the tension stress σ_b, de-veloped by the overturning earthquake moment, just bal-ances the average bearing stress, one can have,

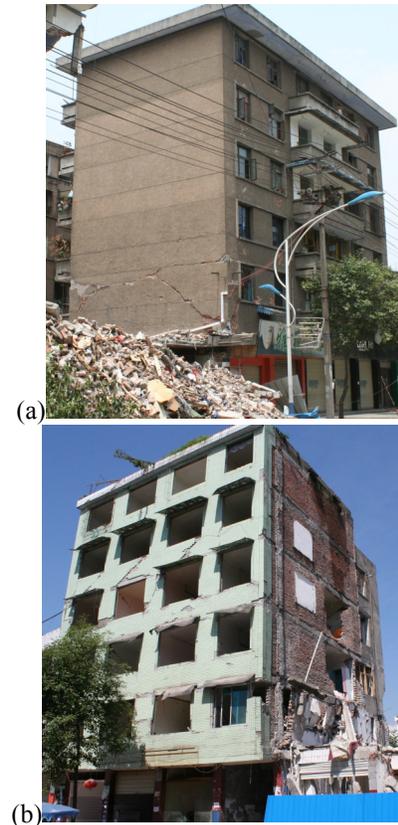
Fig. (11). Damage to exterior masonry walls on top the first floors (**a**) extensive cracks and (**b**) out-of-plane dislocations.

Fig. (12). Damage of confined masonry buildings (**a**), (**b**), and (**c**) partial collapses, (**d**) collapse of simply supported hollow precast slabs, and (**e**) pullout failure of a beam.

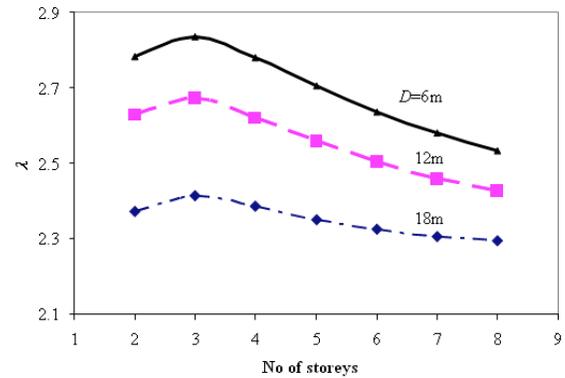
Fig. (14). Variations of drift factor λ against the number of storeys.

To illustrate the application of the abovementioned theory, the masonry building as depicted in Fig. (**4**) is considered again. Assuming a global ductility capacity of 2.5 for brittle masonry buildings, the variations of drift factor to the number of storeys with building depth varying from 6m to 18m determined according to references [12,13] are shown in Fig. (**14**). For the building with a depth of 12m and 6 storeys, λ is found to be 2.50. The corresponding structural period T is found to be 0.457 sec (=0.0463×1.9×18/√12) according to Eq. (10). Assuming the yield inter-storey drift θ_{max} is equal to 0.7% and using Eq. (12), the spectral acceleration capacity S_a is equal to 0.97 g (or 9.52 ms^{-2} =18×0.007×(2π/0.457)^2/2.5) is obtained. This implies that when stronger tie-columns and tie-beam systems are provided, a more deformable swaying failure mode could be enhanced. The lateral strength, in terms of spectral acceleration capacity, could be increased remarkably from 0.57 g to around 1.0 g for 6-storey masonry buildings.

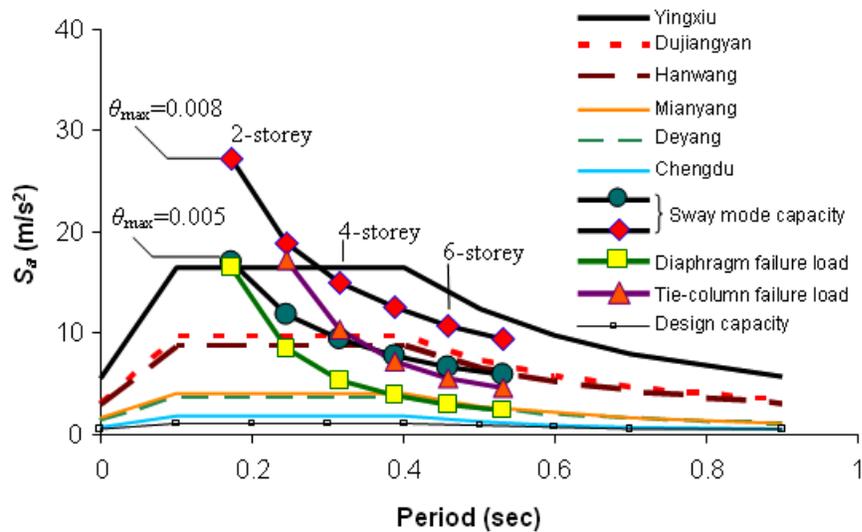
Fig. (15). A comparison of spectra acceleration demands and capacities of masonry buildings in various earthquake affected areas.

By considering the masonry building as shown in Fig. (**4**) and assuming the number of storeys varies from 2 to 7, and β=1.9, the structural period and spectral acceleration capacity of multi-storey masonry buildings were calculated. Fig. (**15**) shows the comparison between the failure strengths, design capacity and the estimated seismic loads (all in terms of spectral accelerations). To take into account the variations of material properties, yield rotations of 0.5% and 0.8% were considered. The design capacity was calculated according to the Chinese seismic design code GB 50011-2001 Clauses 5.1.4 and 5.1.5 [2]. The results show that buildings generally have sufficient lateral strengths in Chengdu, Deyang and Mianyang, while three- to seven-storey buildings in Dujiangyan, Hanwang and Yingxiu could have insufficient strength. Furthermore, the results show that the lateral strength of masonry buildings is very sensitive to building heights. Low-rise masonry buildings with three or fewer storeys are more robust under seismic attacks. Diaphragm failure of these buildings is the most common failure mode. The tie-columns of taller (and usually more slender) masonry buildings are likely to fail under tension due to the high over-turning effect. The loss of confinement to the infill walls could trigger the walls to detach from the main structures and the subsequent out-of-plane dislocations. The structural period of an unrestrained infill wall could be a few seconds, and the displacement demands for long-period structural components in the affected areas could be much higher than 200 mm. Bearing in mind that the actual displacement demands experienced by the infill walls are calculated by adding up the spectral floor displacements and the ground displacements, the peak ground displacements were

Fig. (**15**) shows that the proposed simple strength calculations explain our field observations very well. Apparently, strength, rather than ductility, protected the confined masonry buildings from collapse or serious damage.
