Experimental Investigation of Load Sharing Behavior for Timber Half-Caps of Toodyay Bridge

Abstract: This study investigates the load sharing capabilities for half-caps of a 190m long timber bridge. The bridge has 31 spans over the Avon River in Toodyay, Western Australia. It was constructed from local hardwood timbers and had a series of repairs. However as the width between kerbs was only 5.5 m and it was no footpath it was decided to replace the bridge by a new wider concrete structure. The proposed removal of the existing bridge provided an opportunity to carry out a research program aimed at bridge inspection, estimation of timber material properties, required for more accurate modeling of structural failure as well as selection of improved repair techniques and strengthening methods. Non-destructive evaluation of the bridge prior to construction of a new one was conducted using trucks to provide both static and dynamic loadings. Half-cap load sharing was examined for north and south loading of the bridge deck at the pier and span positions. This paper deals with the results obtained only the north loading case at the pier position. As Toodyay Bridge 631 is a typical timber b

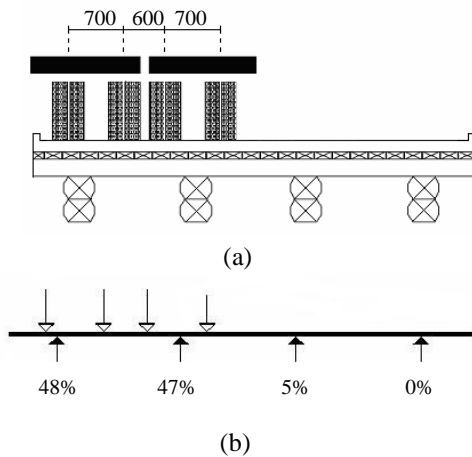
Fig. (6). Expected corbel load distributions along pier for north loading (a) elevation, (b) line diagram.

From Fig. (5), it is evident that the load distributed to corbels 1 and 2 in pier 4 are much different to that, found in piers 1, 2 and 3. In comparison to the expected values, shown in Fig. (6), corbel 1 carried approximately 12% more load than expected, and corbel 2 carried 27% less than expected. In all four piers, the percentage load distribution at corbels 3 and 4 were greater than the expected values, shown in Fig. (6). On average, corbels 3 and 4 carried, respectively, 10% and 5% more load than expected. This may be due to the weaknesses and irregularities in the northern end of the

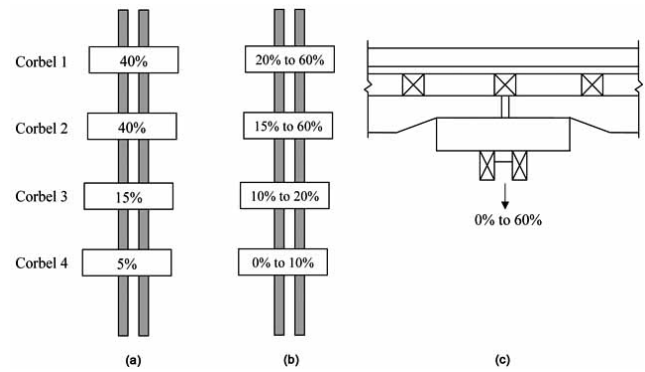
Fig. (11). Corbel load distribution for pier loads (north loading) (a) typical distribution, (b) range of distribution, and (c) possible distribution.

The approximate distribution of the load between corbels in percentage was estimated for each of the applied live load configurations. The values, obtained from analysis of the Toodyay and Goomalling end piers, were combined to determine the corbel load distribution for a typical pier. The average percentage of load that is distributed at each of the corbels on a typical for Bridge 631 pier, under north loading, is shown in Fig. (11). The Figure also indicates the range of corbel percentage load distribution that are possible on other Western Australian timber bridges.

As it follows from the figure, the average load sharing between the half-caps for a typical pier varied from 0% to 60%. However the range of possible load sharing included the case when one half-cap supported the entire live load and a portion of the dead load. Hence, the load sharing capabilities of the half-caps of timber bridges should be further investigated.

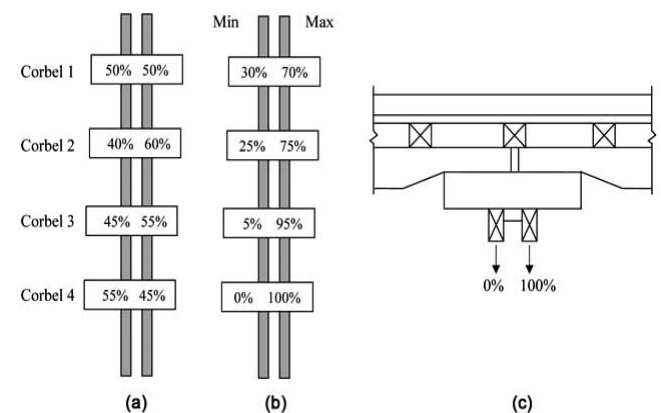
Fig. (18). Load sharing between the half-caps at the corbels for pier loads (north loading) (a) typical distribution, (b) range of distribution, (c) possible distribution.

To determine the half-cap load sharing for a typical pier under north loading, the results from the Toodyay and Goomalling end analysis were combined. Fig. (18) shows the average percentage of load, distributed to the eastern and western half-caps, at each of the corbels on a typical Bridge 631 pier. The figure also presents the range of possible percentage distributions that can be found at each corbel in a typical pier.

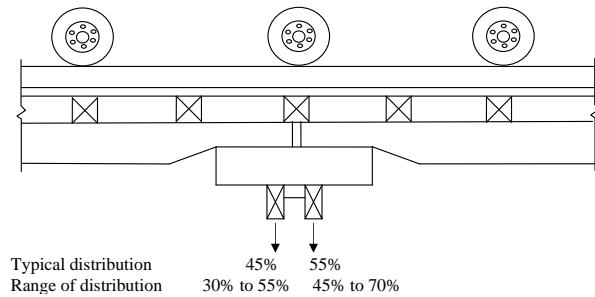
Fig. (19). Typical half-cap load sharing for pier north loading.

The results from the Toodyay and Goomalling end analysis have been combined to determine the half-cap load sharing percentages for symmetric pier live loading. Fig. (19) shows the typical half-cap load sharing for pier north loading. The values, shown in the figure, have been determined by analyzing the test data obtained from north loading of the bridge deck. The figure shows both the average and the expected range of half-cap load sharing percentages for a typical pier on Bridge 631. Following the figure, the half-cap load sharing for a typical pier of the bridge is similar to the expected values. It is also shown that the worst possible percentage of load that was supported by one half-cap of the bridge was 70% of the total pier load.

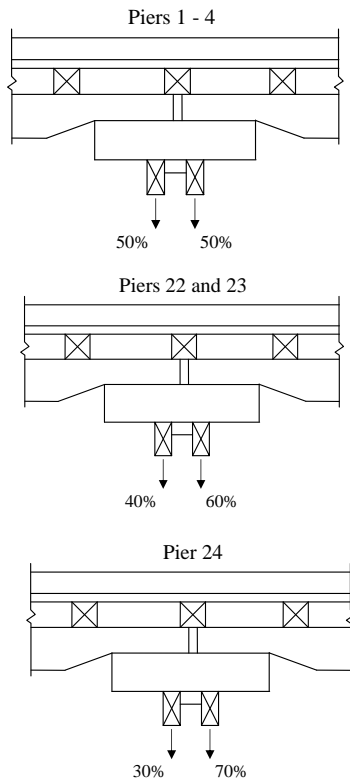
Fig. (20). Load sharing between the half-caps for pier.

The total half-cap load sharing for pier north loading was determined by finding the total load, supported by each of the half-caps. This was achieved by summing the loads, sup-

ported by the eastern and western half-caps, at each of the corbels. The results of the total half-cap load sharing for the Toodyay and Goomalling end piers are shown in Fig. (20).

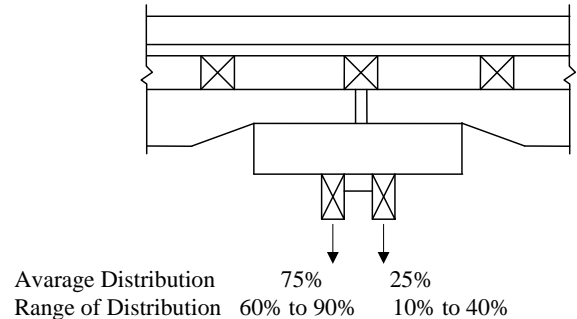
Fig. (21). Approximate half-cap load sharing for pier 21.

Fig. (21) shows the average and range of expected distributions for the half-cap load sharing at pier 21. The values, shown in this figure, are approximations based on the load sharing, obtained from corbels 3 and 4. Comparison of Figs. (20 and 21) shows that the approximated half-cap load sharing percentages for pier 21 were very different, compared to those, obtained for piers 22, 23 and 24. Piers 22, 23 and 24 had a greater percentage of the load, supported by the eastern half-cap, whereas for pier 21 the western half-cap supported the majority of the load.

As explained previously, inspection of the bridge members after testing revealed a large crack, running down the underside of the eastern half-cap at pier 21. The damage to the eastern half-cap affected the local load sharing at corbels 3 and 4, with more load being distributed to the stiffer western half-cap. As the total pier half-cap load sharing was determined using the valid load cell readings at corbels 3 and 4, the approximated load distribution for pier 21 will also reflect this damage. Hence, it is likely that only 25% of the load would be distributed to the eastern half-cap as a result of the large crack.

Another possible reason for the western half-cap, supporting the majority of the load, may be due to the slope of the bridge deck as a result of local jacking. At both piers 21 and 24 the slope of the bridge deck changed due to the local jacking at the piers. In both cases it was found that the majority of the load was supported by the half-caps on the outer side. The eastern half-cap at pier 24 supported the greatest percentage of load, and the western half-cap at pier 21 supported the majority of the load, which may be due to the slope of the bridge at these locations.
