Experimental Investigation of Load Sharing Behavior for Timber Half-Caps of Toodyay Bridge

Abstract: This study investigates the load sharing capabilities for half-caps of a 190m long timber bridge. The bridge has 31 spans over the Avon River in Toodyay, Western Australia. It was constructed from local hardwood timbers and had a series of repairs. However as the width between kerbs was only 5.5 m and it was no footpath it was decided to replace the bridge by a new wider concrete structure. The proposed removal of the existing bridge provided an opportunity to carry out a research program aimed at bridge inspection, estimation of timber material properties, required for more accurate modeling of structural failure as well as selection of improved repair techniques and strengthening methods. Non-destructive evaluation of the bridge prior to construction of a new one was conducted using trucks to provide both static and dynamic loadings. Half-cap load sharing was examined for north and south loading of the bridge deck at the pier and span positions. This paper deals with the results obtained only the north loading case at the pier position. As Toodyay Bridge 631 is a typical timber b

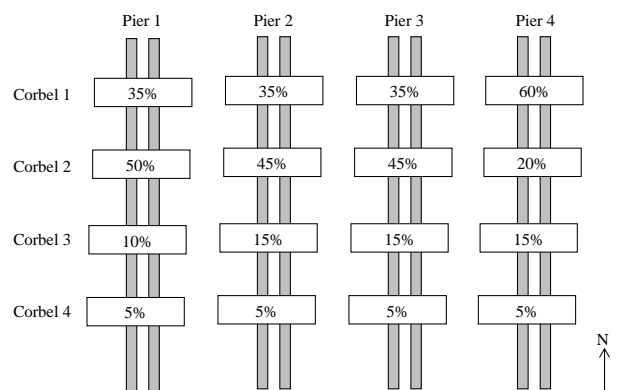
Fig. (5). Load distribution between corbels in toodyay end piers (pier - north loading).

The values, shown in Fig. (5), were determined by averaging the results of the corbel load distribution at each pier for load configurations 1, 2, 3 and 4. The figure shows that the load distributed at each of the corbels is the same for piers 2 and 3. These two piers, however, do not represent the expected values, shown in Fig. (6), as corbel 2 is takes 10% more load than corbel 1. Possible explanation for pier 2, corbel 1, behaving worse than expected, could be attributed to the condition of pile 1.

Pile 1 contains no solid timber, as rot has extended throughout the entire thickness of the pile. The deteriorated area of the pile has been shaded, and the numbers on each face of the pile represent how much solid timber remains. Because of the deterioration, a steel column was driven adjacent to pile 1 during the research, to carry the load. Before it was done, it is possible that the half-caps may have settled, resulting in the transfer of a portion of the load to pile 2. Further indicated that there were minor heartwood splits to the half-caps above pile 1. It is possible that it also led to the transfer of load to corbel 2, as the heartwood is the hardest, most dense wood, and provides the majority of the half-caps stiffness. Hence, any damage or deterioration to the heartwood can reduce the strength of the half-caps [15].

Possible reasons for pier 3, corbel 1, behaving worse than expected, could also be attributed to the condition of pile 1 and the overlying half-caps. Pile 1 was found to have “major termite damage” to the outer bark layers on two faces of the pile. The western half-cap above pile 1 also contained a horizontal growth ring split. Thus, lower than expected percentage load, distributed to corbel 1, may be due to a combination of the split to the half-cap and the termite damage to the pile.

Pier 1 has a similar corbel percentage load distribution to piers 2 and 3. Corbel 1 was found to take 15% less load than corbel 2, which is most likely due to the condition of pile 1. Pile 1 is shown to have extensive rot to the heartwood, as shown in Fig. (7). It also contains a “knot” approximately 2.2 metres above the waler. Therefore, the load distribution at corbel 1 may have been affected by the deterioration and natural weaknesses in pile 1.

From Fig. (5), it is evident that the load distributed to corbels 1 and 2 in pier 4 are much different to that, found in piers 1, 2 and 3. In comparison to the expected values, shown in Fig. (6), corbel 1 carried approximately 12% more load than expected, and corbel 2 carried 27% less than expected. In all four piers, the percentage load distribution at corbels 3 and 4 were greater than the expected values, shown in Fig. (6). On average, corbels 3 and 4 carried, respectively, 10% and 5% more load than expected. This may be due to the weaknesses and irregularities in the northern end of the

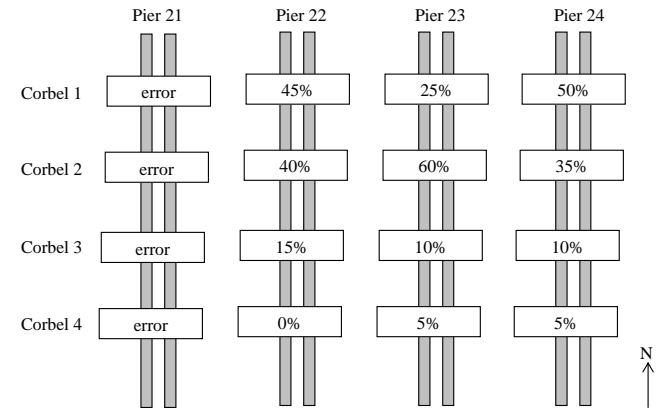
Fig. (8). Load distribution between corbels in Goomalling end piers (pier - north loading).

As it can be followed from Fig. (8), under north loading the corbel load distribution at the Goomalling end of the bridge is much different, compared to that, found at the Toodyay end. It is evident that corbels 1 and 2 in pier 22 supported slightly less loads than the expected values (see Fig. 6). This load was transferred to corbel 3, which supported approximately 10% more load than expected. Possible reasons for the northern corbels in pier 22 performing worse than expected can be found in Fig. (9). There was termite damage to the half-caps above pile 1 (see Fig. 9). There was also deterioration to pile 1 in pier 22, however, a universal column had been driven adjacent to pile 1 to support the load.

By analyzing the results, presented in Fig. (8), it can be concluded that the percentage load distribution at corbels 1 and 2 in pier 23 significantly differs from the expected values, shown in Fig. (5). Corbel 1 supported approximately 23% less load than expected. The load was transferred and supported by corbel 2. Possible reasons for the northern corbel in pier 23, behaving worse than expected, is due to the condition of the half-caps above pile 1.

During inspection of the bridge 631, a large “pipe”, located in the eastern half-cap, at the southern end of pier 23, was observed. This pipe was caused by deterioration (or rotting) of a tubular section of timber within the half-cap. This form of deterioration can reduce the strength of the half-cap significantly, affecting the distribution of load to the corbel. The pipe was approximately 120 mm in diameter and 1 m in length, as illustrated in Fig. (10). The values, obtained from the corbel load sharing analysis, at the southern end of pier 23, were similar to those, found at the other piers. Therefore it appears that the pipe in the half-cap did not affect the load sharing at the southern corbels in pier 23.

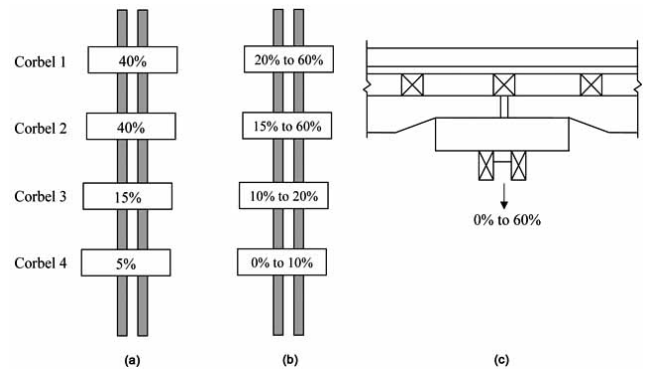
Fig. (11). Corbel load distribution for pier loads (north loading) (a) typical distribution, (b) range of distribution, and (c) possible distribution.

The approximate distribution of the load between corbels in percentage was estimated for each of the applied live load configurations. The values, obtained from analysis of the Toodyay and Goomalling end piers, were combined to determine the corbel load distribution for a typical pier. The average percentage of load that is distributed at each of the corbels on a typical for Bridge 631 pier, under north loading, is shown in Fig. (11). The Figure also indicates the range of corbel percentage load distribution that are possible on other Western Australian timber bridges.

As it follows from the figure, the average load sharing between the half-caps for a typical pier varied from 0% to 60%. However the range of possible load sharing included the case when one half-cap supported the entire live load and a portion of the dead load. Hence, the load sharing capabilities of the half-caps of timber bridges should be further investigated.

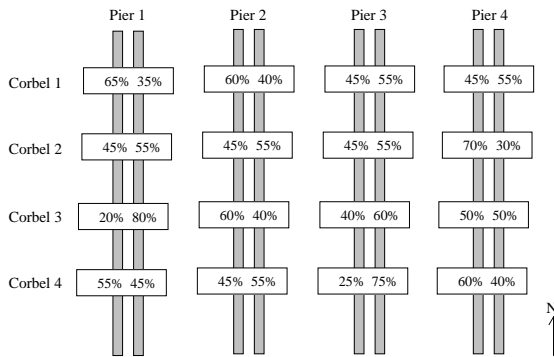
Fig. (13). Load distributed between the eastern and western half-caps in the Toodyay end piers (pier - north loading).

Fig. (13) shows that the load sharing ratios at corbels 2 and 4 in pier 1 have the same range, but they are much different to the ratios, found at corbels 1 and 3. The unexpected load sharing ratio at corbel 3 may be attributed to the condition of pile 3 and the western half-cap. Investigation of the bridge members after testing indicated that the top of pile 3 had deteriorated more on the western side. It was also found that the underside of the western half-cap had weathered where it sits upon pile 3, as shown in Fig. (14).

A combination of the deterioration to the half-cap and the top of pile 3 produced an uneven surface for the western half-cap to sit upon. Although this has not affected the load sharing ratio at corbel 4, it may be the cause of the unexpected values, obtained at corbel 3, as the western half-cap was found to support only 20% of the load. Fig. (14) demonstrates that these observations did not affect the load sharing at corbel 4.

In pier 2, corbels 2 and 4 had load sharing ratios, which were similar to the expected values. Corbels 1 and 3 also had the same load sharing ratios, but only 40% of the load was distributed to the eastern half-cap in both cases. The unexpected ratio at corbel 1 may be attributed to the replacement of pile 1. As it was mentioned above, the original timber pile 1 contained no solid timber as rot had extended throughout its entire thickness. The shaded portion in gray in the figure shows the area of the pile affected by rotting, reducing the bearing life of the pile. Prior to the new steel universal column being driven to replace pile 1, it is possible that the half-caps may have settled unevenly, producing an uneven distribution of load between the half-caps.

It is evident from Fig. (13) that the northern corbels in pier 3 had different load sharing ratios, compared to the southern one. Northern corbels 1 and 2 had load sharing ratios, which were similar to the expected values. The southern corbels 3 and 4 were found to have uneven load sharing ratios. In particular, at corbel 4 only 25% of the load was distributed to the western half-cap. In pier 4, corbel 3 had the expected 50:50 load sharing ratio, and corbel 1 also had a similar distribution. Corbels 2 and 4, however, had uneven load sharing ratios with the western half-caps supporting a greater percentage of the load. Possible reasons for unexpected behaviour of corbel 4 could be the condition of pile 3.

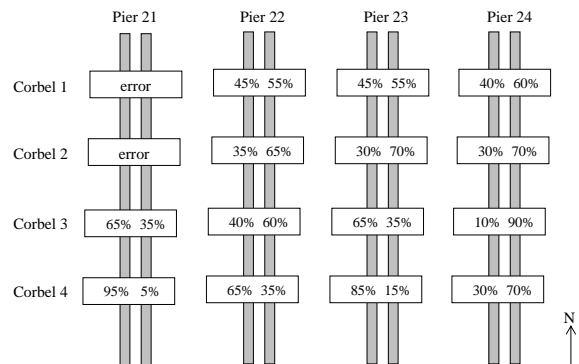
Fig. (15). Load distributed between the eastern and western half-caps in the Goomalling end piers (north loading).

From Fig. (15) it is evident that corbels 3 and 4 in pier 21 do not behave as expected. In particular, at corbel 4 the eastern half-cap supported only 5% of the load. The MRWA Inspection Report [9] and the observations, made during testing, did not indicate that there was any damage to the southern end of pier 21. However, inspection of the bridge structure after testing revealed a large crack at the entire length of the underside of the eastern half-cap. This crack is shown at the northern end of pier 21 in Fig. (16). It is the likely cause of the lower than expected distribution at the southern corbels.

Corbel 1 in pier 22 had a similar load sharing ratio to the expected values, whereas corbels 2, 3 and 4 were found to have unequal load distributions. It was also observed during testing that the eastern half-cap at the southern end of pier 22 was not vertical and as a result, could not support as much load as the western half-cap. It has moved up to 5 mm under loading, when the jacking frame was in place. These are the likely reasons for the eastern half-cap supporting less load than expected.

The percentage load distribution to the eastern and western half-caps at corbel 1 in pier 23, were very similar to the expected values. It has not affected the load transferred to the western half-cap as it was only slightly less than expected. In pier 23 the western half-cap at corbel 2 supported only 30% of the load. Fig. (15) indicates that corbel 4 in pier 23 has load sharing values much different than the expected ones. The eastern half-cap was found to support on average only 15% of the load. The likely cause of this is the large pipe that was located in the eastern half-cap at the southern end of pier 23 (see Fig. 10). This pipe has reduced the cross-sectional area of the eastern half-cap, and in turn, caused a reduction in its transverse compressive stiffness. This explains why the majority of the load was supported by the stiffer western half-cap. The pipe may have also contributed towards the lower than expected distribution of load to the eastern half-cap at corbel 3.

From Fig. (15) it can be seen that the load sharing percentages at all four corbels in pier 24 are very different from the expected values. At all four corbels the lowest percentage of load was distributed to the western half-cap indicating that it possibly contained a flaw or weakness. The western half-cap supported 40% of the load at corbel 1, 30% at corbels 2 and 4, and only 10% at corbel 3. The MRWA Inspection Report [9] did not indicate that there were any weaknesses in either half-cap, and neither did the observations that were made during testing. However, upon completion of the testing, inspection of the bridge structure revealed a large crack running down the inside of the western half-cap, as shown in Fig. (17).

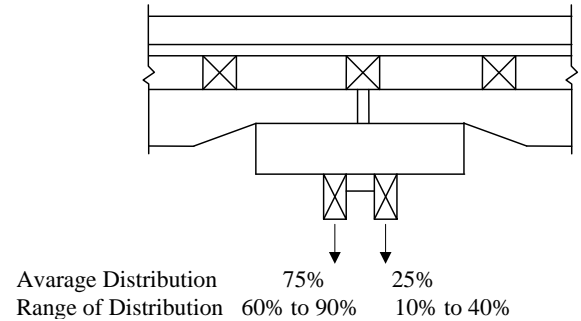
Fig. (21). Approximate half-cap load sharing for pier 21.

Fig. (21) shows the average and range of expected distributions for the half-cap load sharing at pier 21. The values, shown in this figure, are approximations based on the load sharing, obtained from corbels 3 and 4. Comparison of Figs. (20 and 21) shows that the approximated half-cap load sharing percentages for pier 21 were very different, compared to those, obtained for piers 22, 23 and 24. Piers 22, 23 and 24 had a greater percentage of the load, supported by the eastern half-cap, whereas for pier 21 the western half-cap supported the majority of the load.

As explained previously, inspection of the bridge members after testing revealed a large crack, running down the underside of the eastern half-cap at pier 21. The damage to the eastern half-cap affected the local load sharing at corbels 3 and 4, with more load being distributed to the stiffer western half-cap. As the total pier half-cap load sharing was determined using the valid load cell readings at corbels 3 and 4, the approximated load distribution for pier 21 will also reflect this damage. Hence, it is likely that only 25% of the load would be distributed to the eastern half-cap as a result of the large crack.

Another possible reason for the western half-cap, supporting the majority of the load, may be due to the slope of the bridge deck as a result of local jacking. At both piers 21 and 24 the slope of the bridge deck changed due to the local jacking at the piers. In both cases it was found that the majority of the load was supported by the half-caps on the outer side. The eastern half-cap at pier 24 supported the greatest percentage of load, and the western half-cap at pier 21 supported the majority of the load, which may be due to the slope of the bridge at these locations.
