# The Open Construction and Building Technology Journal

# Losses and Productivity Parameters for Cladding Technology with Wet-Process Sprayed Mortar

Denise Ribeiro dos Santos, Gabriela Alves Tenório de Morais\* and Alberto Casado Lordsleem Jr.

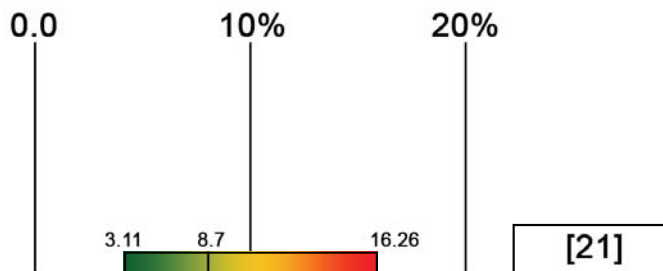
According to research by [21], it was possible to indicate reference values for losses of industrialized mortar applied in internal areas using the wet-process sprayed mortar. Fig. (1) shows the minimum, average, and maximum values obtained by [21].

Fig. (1). Losses of industrialized mortar in internal cladding.

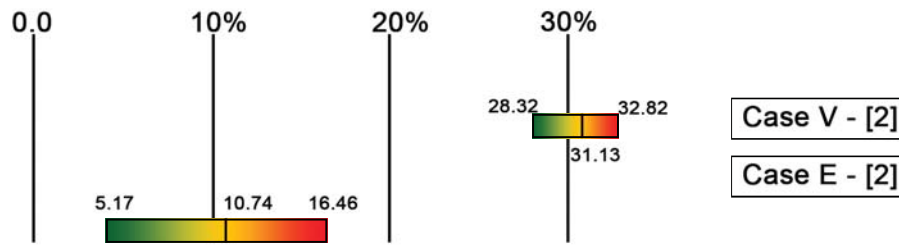
According to projects evaluated by [2], the losses of industrialized mortar in external cladding ranged from 5.17% to 32.82%, as shown in the Fig. (2).

Fig. (2). Losses of industrialized mortar in external cladding.

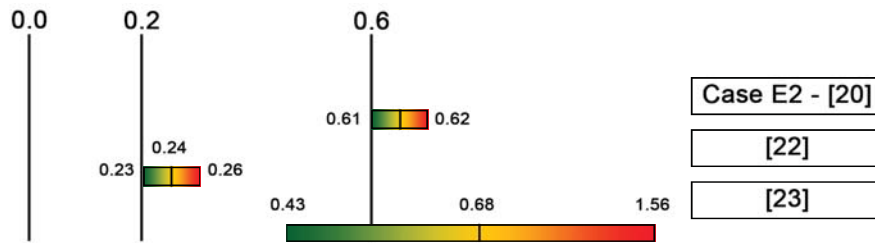
Based on the researches by [20] and [22], reference values for labor productivity were gathered in the execution of the wet-process sprayed mortar in internal cladding, as shown in Fig. (3).

Fig. (3). Productivity (M'hr/m²) for internal cladding.

According to Fig. (3), the productivity values evidenced by [22] were better than those obtained by [20] in case E2. While [22] observed variations from 0.23 to 0.26 M'hr/m², with an average of 33 m²/day/man [20], observed variations around 0.62M'hr/m² or 12.9 m²/day/man.

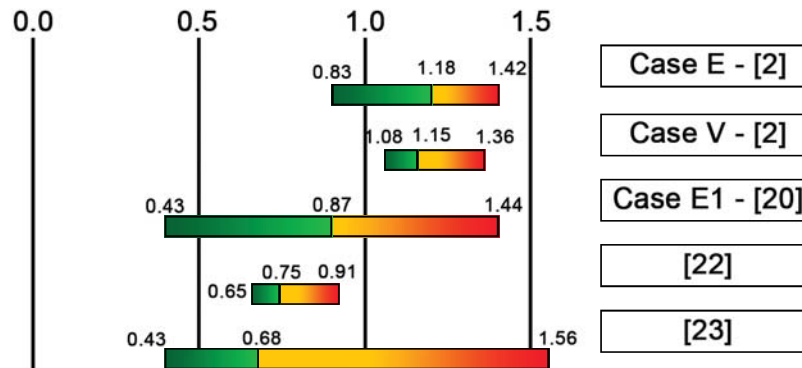
Fig. (4) represents the reference values for the productivity of cladding execution in external areas, according to the research studies [2], [20] and [22], indicating the minimum, average, and maximum values obtained in their case studies, including the range established by TCPO 14 [23].

Fig. (4). Productivity (M'hr/m²) for external cladding.

According to the values shown in Fig. (4), the productivity shown by [2] in Case E, with a variation from 0.88 to 1.42 M<sup>3</sup>/hr/m<sup>2</sup> [20], in Case E1, with a variation from 0.43 to 1.44 M<sup>3</sup>/hr/m<sup>2</sup>, and [22], with a variation from 0.65 to 0.91 M<sup>3</sup>/hr/m<sup>2</sup> are consistent with the range of values established by TCPO 14 [23].

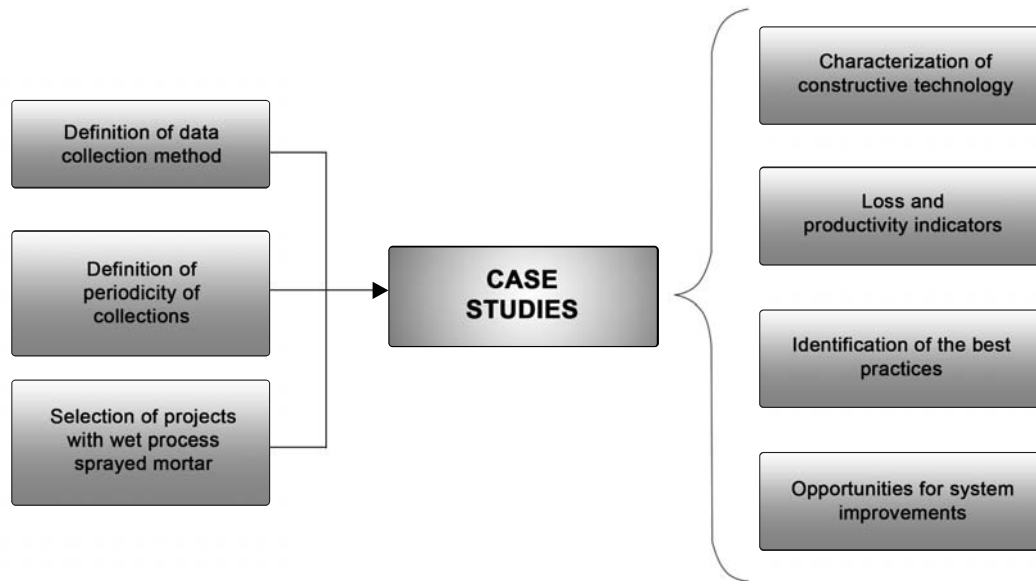
The methodology for conducting field research is illustrated in Fig. (5).

Fig. (5). Field research methodology scheme.

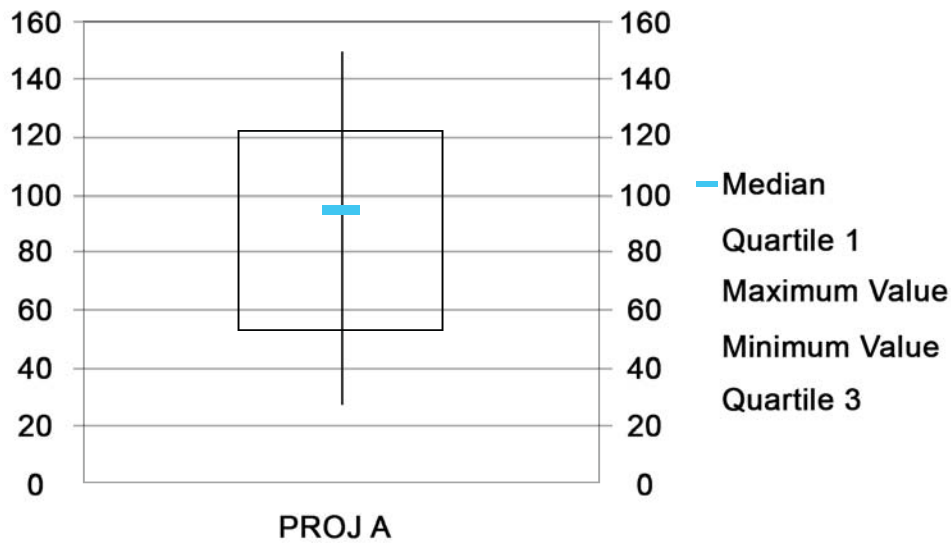
As Table 6 shows, project A was the only one in this research with wet-process sprayed mortar cladding in internal areas. Fig. (6) represents the box plot of loss values.

Fig. (6). Industrialized mortar losses in internal area (%).

Considering a coefficient of variation equivalent to 45%, the loss data collected in project A constitute a distribution classified as high dispersion, being higher than 30%, with values varying from 27.93% to 150.02%. From the Box Plot presented, 50% of the loss index for project A was between 53.26% and 122.29% (quartile 1 and quartile 3, respectively).

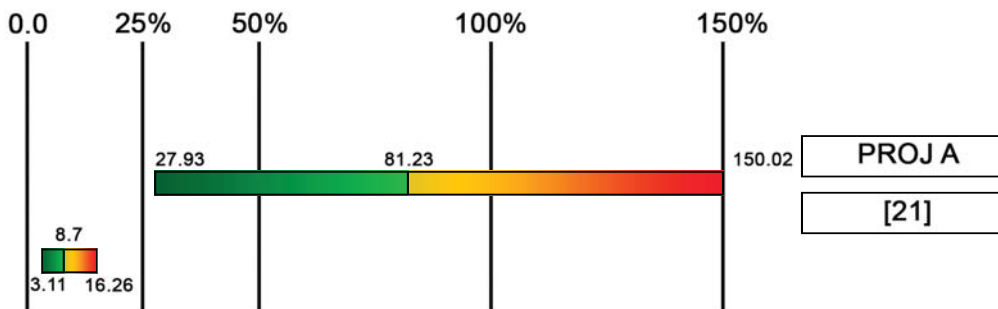
Fig. (7). Comparison of industrialized mortar losses (%) from project A and reference studies.

As it can be observed in Fig. (7), the loss values for A were higher than those found by [21], which varied from 3.11% to 16.26%, taking into account that they are projects with the same production system and that the mortar application occurred in internal areas. As most loss values for project A were higher than 53%, with an average of 81.23%, it can be considered that the industrialized mortar losses in this project were high.

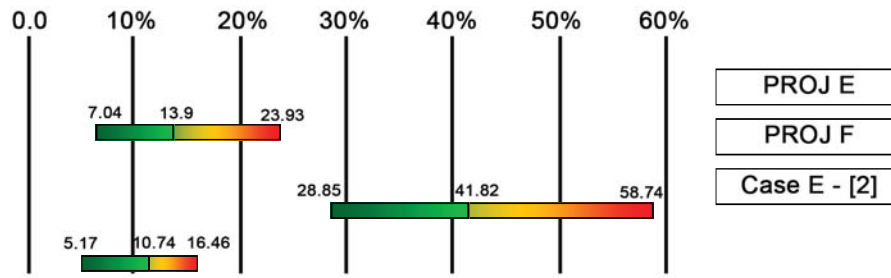
Fig. (9). Comparison of industrialized mortar losses (%) from projects E and F and reference studies.

According to Fig. (9), the average loss value in work E is close to the value found by [2] in case E. The losses found in F were higher than the results of [2].

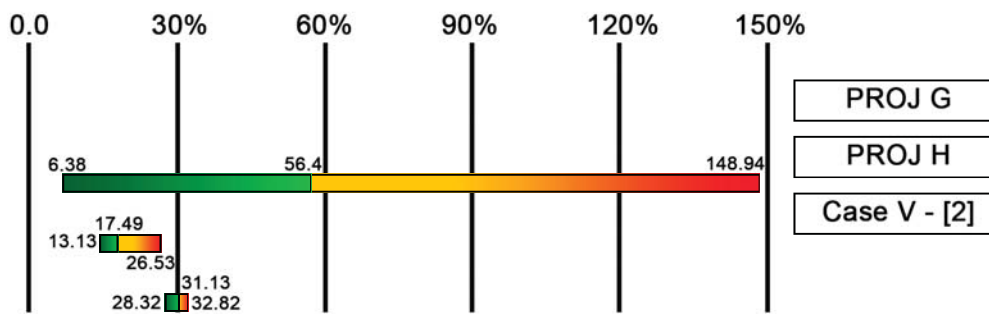
Fig. (10). Comparison of industrialized mortar losses (%) from projects G and H and reference studies.

Fig. (10) shows variations in projects G and H as well as in case V of [2]. Based on the data presented in this graph, it can be seen that project G presents both the lowest and the highest loss index, and that project H presents the best loss result, considering the average value of all averages presented.

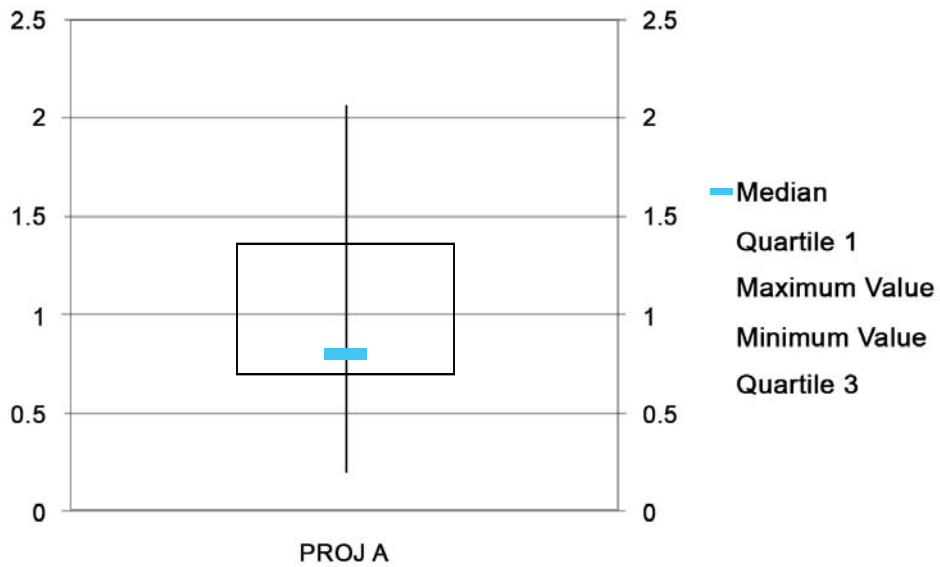
Fig. (11) shows a box plot of masons' productivity values in M'hr/m<sup>2</sup> from project A.

Fig. (11). Masons' productivity (M'hr/m<sup>2</sup>) in internal claddings.

According to the analysis in the graph above, the weekly productivity index for project A ranged from 0.21M<sup>3</sup>/hr/m<sup>2</sup> to 2.06M<sup>3</sup>/hr/m<sup>2</sup> with a variation coefficient of 48%, indicating a high data dispersion, with half of these values concentrated in a range from 0.7M<sup>3</sup>/hr/m<sup>2</sup> to 1.36M<sup>3</sup>/hr/m<sup>2</sup>. Among the factors that favored the team’s productivity, it is possible to highlight: workmanship with experience in wet-process sprayed mortar, average thickness of the cladding layer ranging from 0.7cm to 1.0cm, and application in internal areas.

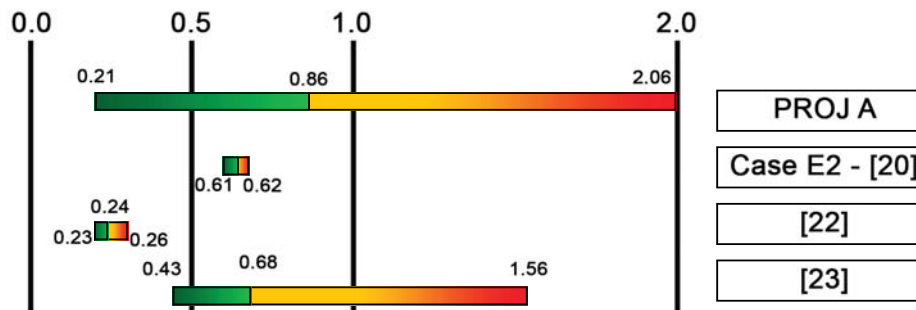
Fig. (12). Comparison of productivity (M<sup>3</sup>/hr/m<sup>2</sup>) in A and reference studies.

Comparing, according to Fig. (12), A’s productivity values and the values obtained in [20] and [22] surveys, for internal cladding, it is noted that the RUP mean and maximum values in project A are higher than the results found by those authors.

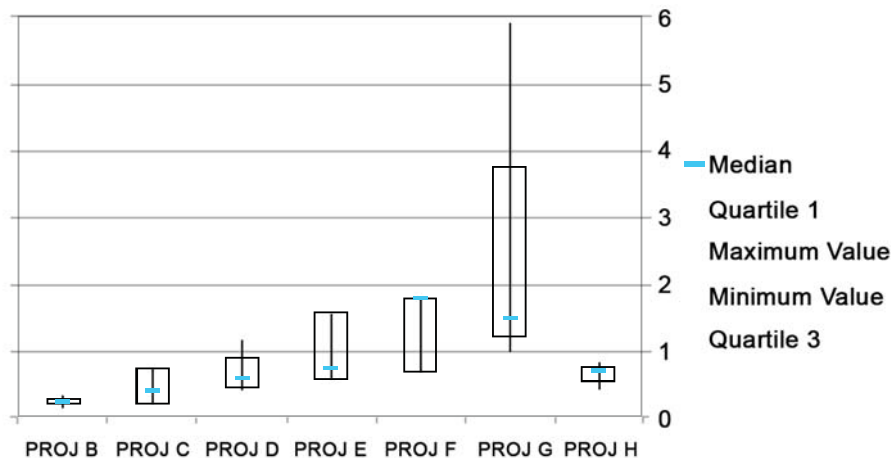
Fig. (13) indicates box plots for the analyzed projects with mortar cladding in external areas.

Fig. (13). Masons’ productivity (M<sup>3</sup>/hr/m<sup>2</sup>) in external cladding.

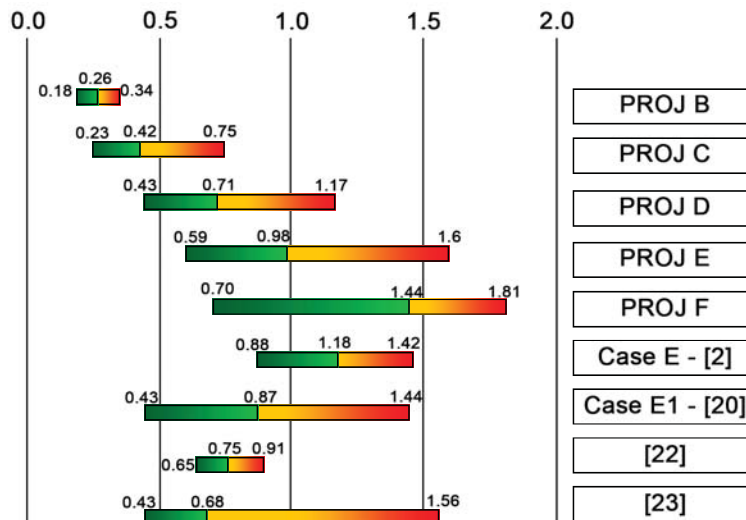
The following works were compared: the productivity data obtained in projects B, C, D, E, F with the values found by [2] for case E [20], for Case E1 [22], and TCPO 14 [23]. Fig. (14) indicates the minimum, average and maximum results of the analyzed works together with the values found in the literature.

Fig. (14). Comparison of productivity (M<sup>3</sup>/hr/m<sup>2</sup>) in B, C, D, E and F and reference studies.

According to Fig. (14), the result variations in B and C constitute the best productivity results among the analyzed ones. The results of D are consistent with the variations obtained in case E1 of [20] and [22]. The projects E and F presented minimum values consistent with the reference studies, but the maximum RUP values are higher than those predicted by [20] and [22]. Considering the average productivity value obtained, these are within the reality of the reference studies and TCPO 14 [23].

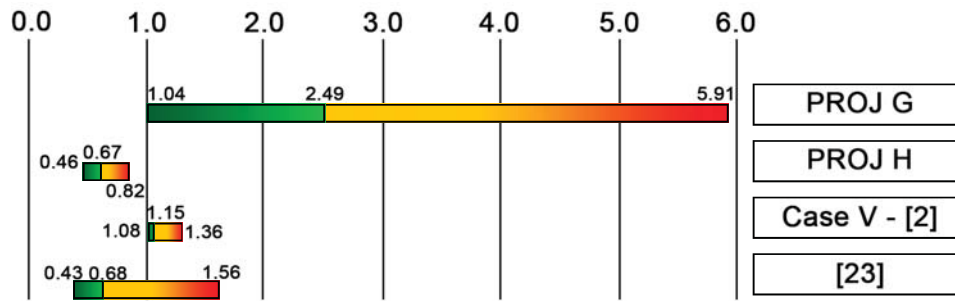
Fig. (15). Comparison of productivity (M³/hr/m²) in G and H and reference studies.

According to Fig. (15), project H obtained productivity values higher than case V in [2], since the maximum RUP value in H is lower than the minimum value of RUP in [2]. The minimum RUP value in G is consistent with the results of [2], but presents the average and maximum values outside the reality found in project H and case V in [2]. Regarding the values established by TCPO 14 [23], H presents coherent variations while G presents discrepant variations.

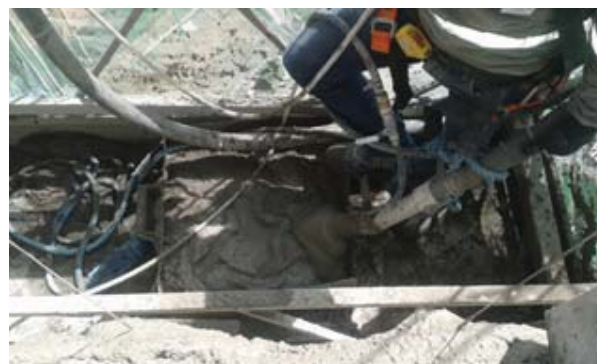
One practice observed in project E was the mortar packing as it is released from the hose, when the pump was switched off, in containers for later use. This material was commonly reused either in the projection or execution of cladding finishing itself. With this practice, residues from the system were minimized. Fig. (16) shows a worker directing the mortar into a container after turning the equipment off.

Fig. (16). Containment of mortar return.

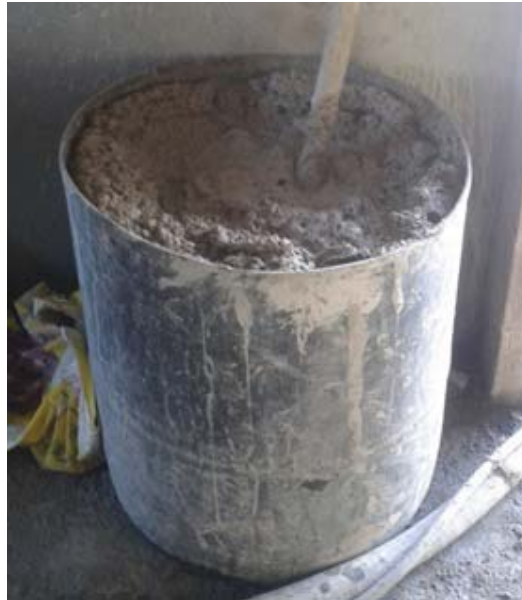
With respect to the wastes generated during the equipment cleaning, these were packed in containers, as shown in Fig. (17). This material was rested until the solid part decanted and then went to segregation, in which the liquid part of the mixture was reused to clean the hose and the solid part was bagged and transported to the ground floor in a suitable location, awaiting final disposal. This practice has implications for the rational use of water, in the act of cleaning, and minimizes the spreading of material in the work area, but it still causes loss. This is an aspect that deserves attention regarding waste management.

**Fig. (17).** Packaging of waste from equipment cleaning.
