# The Investigation of Stability on Slopes Utilizing Reinforcement Gabion Walls and Concrete Piles for Mitigating Landslide Disasters

**Aim:** This article aimed to evaluate the effect of installing gabions and piles for safety measures on the stability of slope landslides. The analysis of slope stability was performed utilizing the Plaxis 2D software. For reinforced slopes, the Safety Factor (SF) value utilized as a benchmark for evaluating slope stability was  $SF \geq 1.5$ .

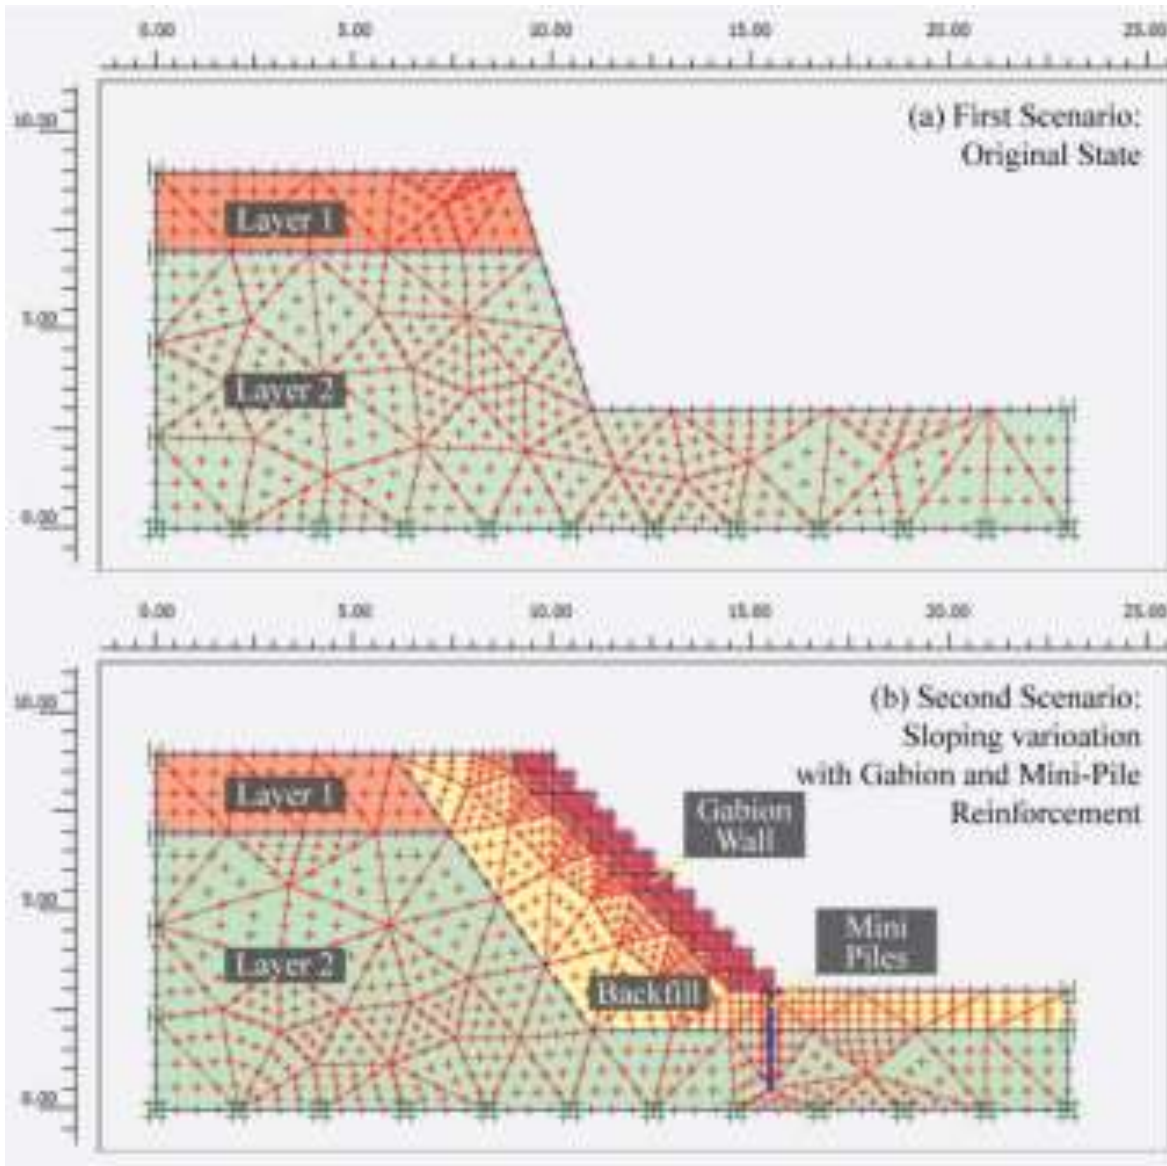
Fig. (2). Scenarios of gabion wall and minipile design for slope reinforcement.

Additionally, the study examined slope stability reinforcement through the analysis of three scenarios: without the use of retaining walls, with the use of retaining gabion walls, and with the use of gabion walls in combination with concrete minipiles. The construction of gabion walls with a combination of concrete minipiles was planned based on the considerations specified in Table 2. Before determining the proper position of the gabion walls for soil retention, it is essential to evaluate the extent of the landslide area on the slope. The location of the soil-retaining gabion wall, in conjunction with the positioning of concrete minipiles, may affect the Safety Factor (SF) of the slope. If the SF satisfies the minimum criteria, the option of utilizing a soil-retaining gabion wall combined with minipiles becomes feasible for installation. If multiple positions fulfill the slope stability safety factor requirements, the placement that is most efficient and cost-effective is preferred.

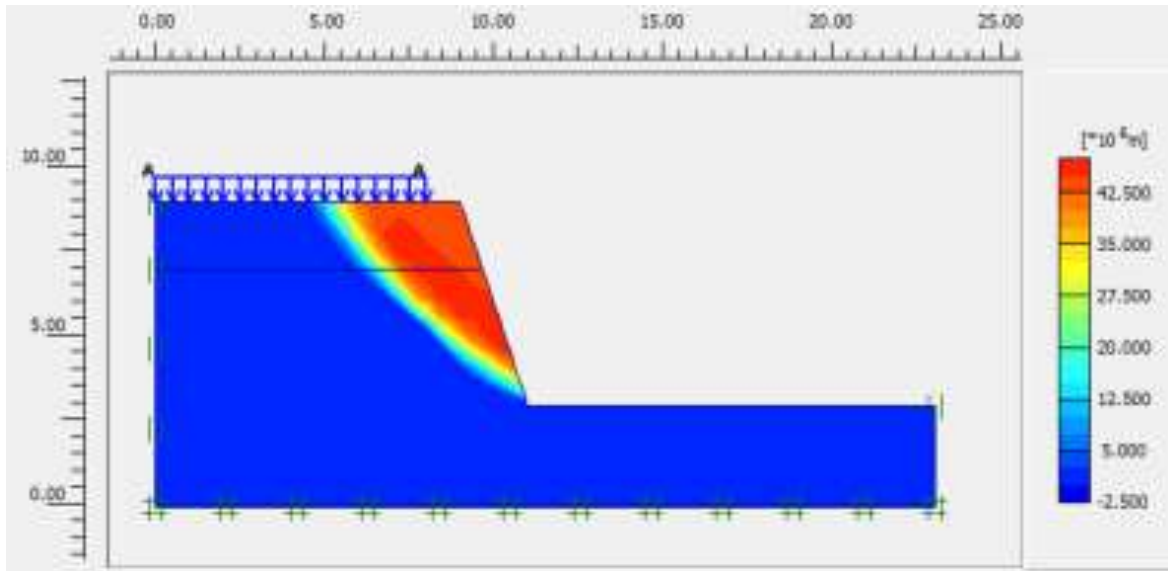
**Fig. (3).** Unreinforced slope results from the plaxis analysis.

Field observations from several viewpoints indicated the landslide to be of the rotating type, characterized by the movement of soil and rock masses along a concave-shaped sliding plane. The research input from the Plaxis analysis, depicted in Fig. (3), revealed the geometry of the landslide area to closely resemble the patterns observed in the field. Based on the results, the SF for an unreinforced slope was 1.11, indicating an unstable slope. Furthermore, Fig. (4) displays the results of the Plaxis analysis, specifically the slope with reinforcement of gabions and concrete minipiles.

Table 3 displays the quantitative effects of the gabion arrangement as well as the combined effect of gabions with concrete minipiles on the slope safety factor. The computation of the slope safety factor revealed the SF in the no-reinforcement state to be  $SF = 1.11$ , indicating landslide events aligning with the actual conditions on the site. Furthermore, the slope model with reinforcement yielded SF calculation results that all exceeded 1.5, indicating stable slope conditions. This condition was present on slopes that had reinforcement at all angles, except for slopes with a 90-degree angle when the SF was less than 1.5.

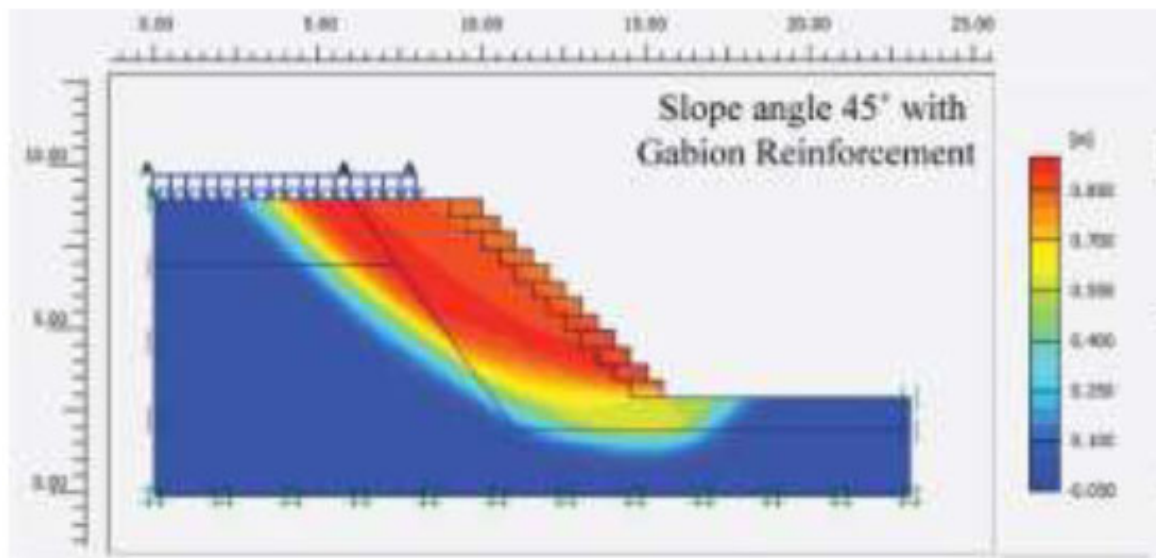
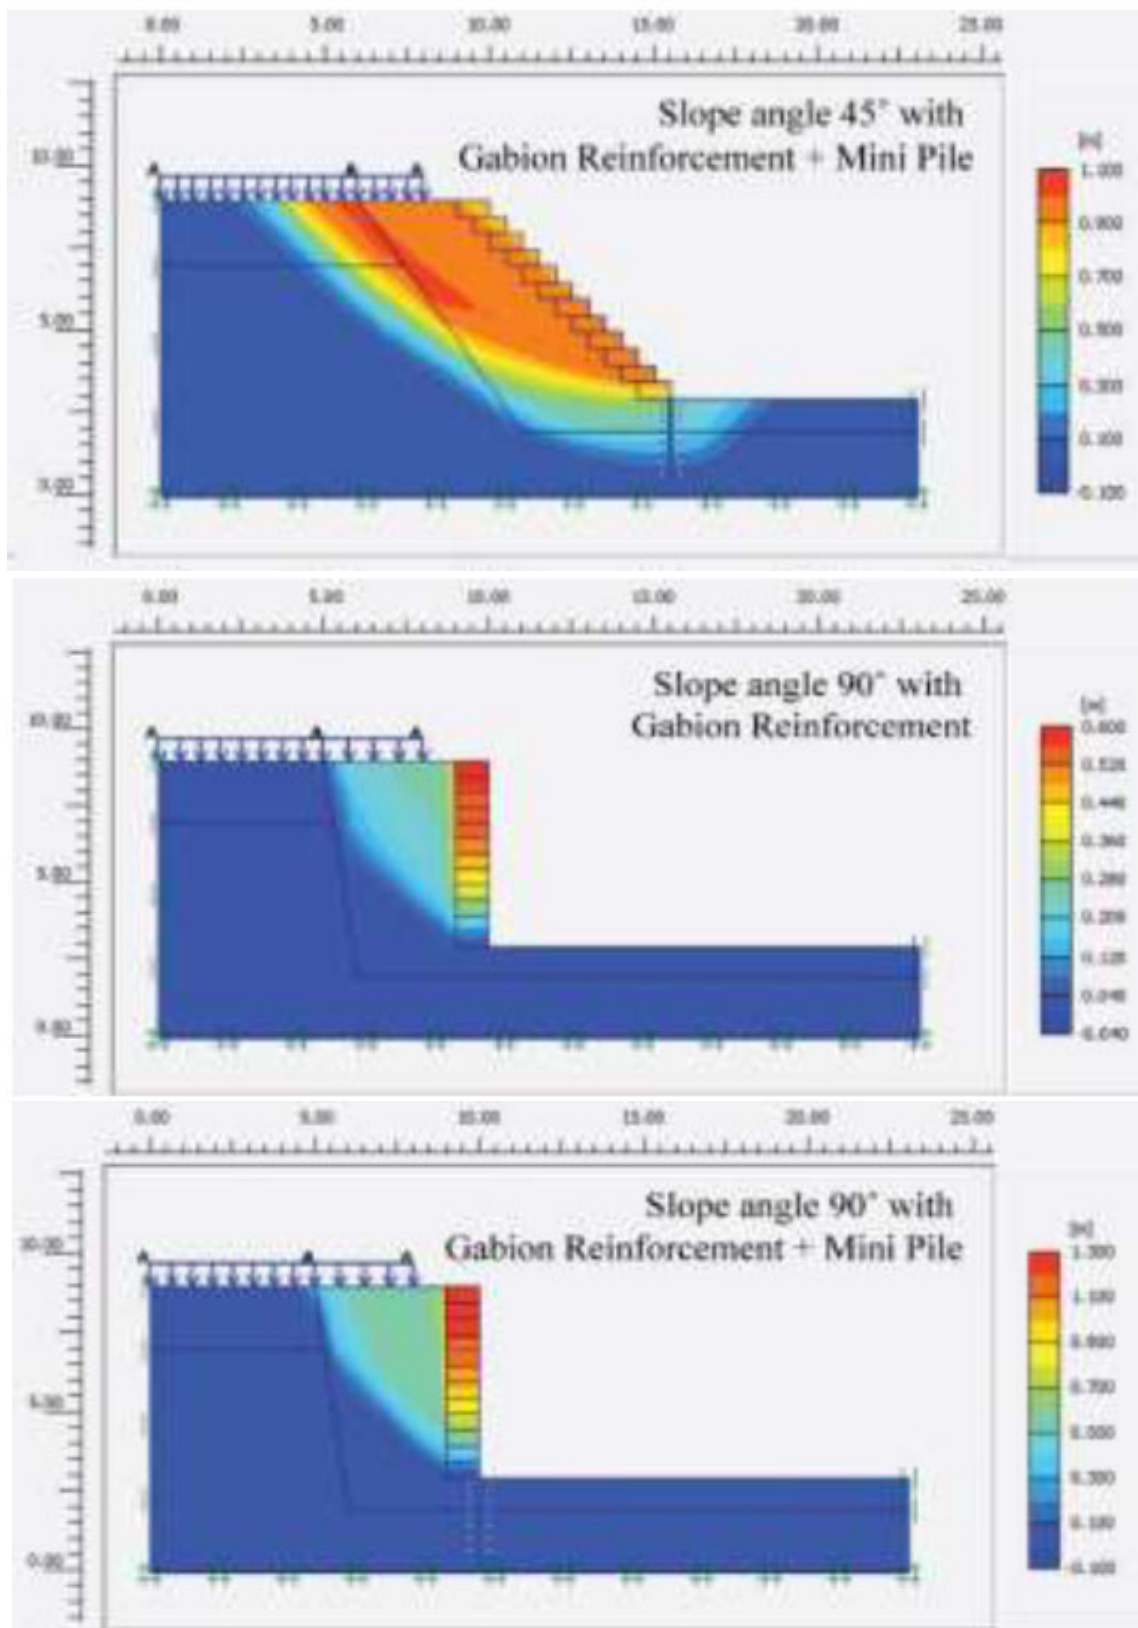
Fig. (4). Slope results with reinforcement of gabions and concrete minipiles from the plaxis analysis.

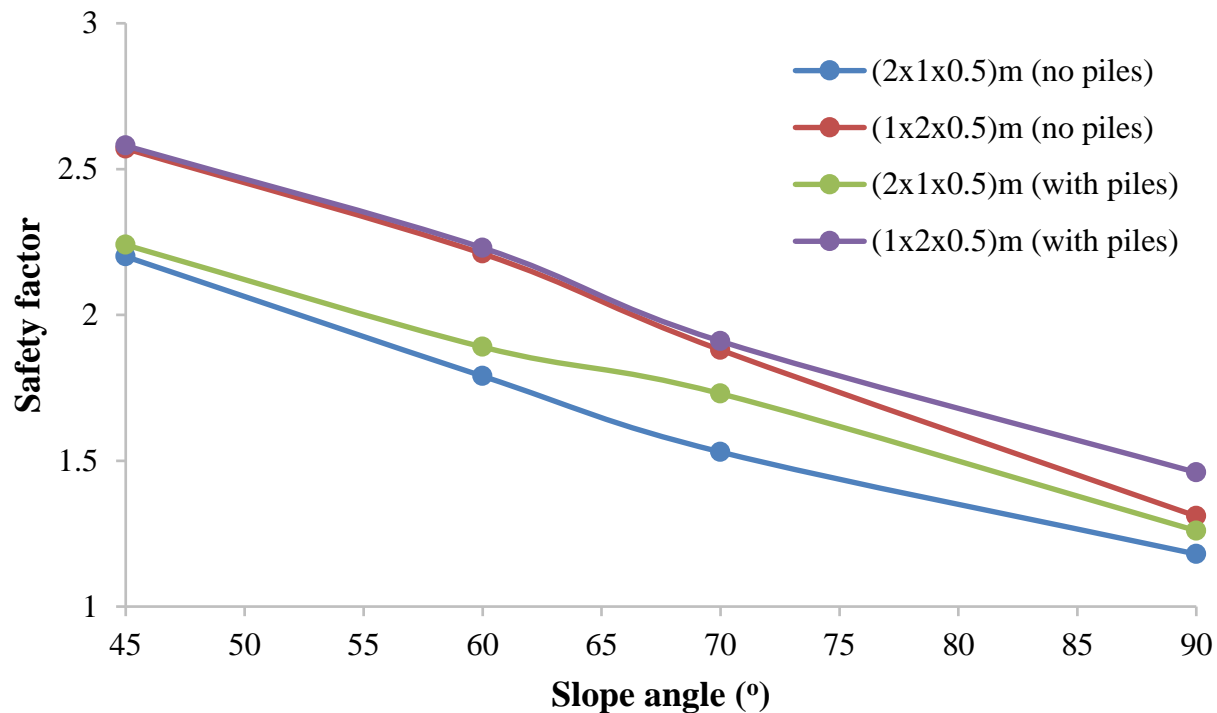
**Fig. (5).** Relationship among the gabion, minipiles, and the safety factor.

Fig. (5) plots the findings of the analysis related to the effects of concrete minipiles on the combination model incorporating gabions. The results indicated that the utilization of minipiles affected the safety factor of the slope. In contrast to the strengthening model that solely employed gabions, enhancing the safety factor of the slope with concrete minipiles was possible when gabions were utilized in conjunction with minipiles. Additionally, as the angle of the slope decreased, the safety factor increased, specifically  $SF > 1.5$ . Conversely, an increase in slope angle resulted in a corresponding reduction in the slope's safety factor ( $SF < 1.5$ ), indicating the slope to no longer be secure even at a 90-degree angle.

In addition, as presented in Fig. (5), the study determined the influence of the slope angle on the slope safety factor. A decrease in the slope angle led to an increase in the safety factor. Conversely, when the slope angle increased, the safety factor decreased. At a slope angle of 90 degrees, the slope safety factor was less than

1.5, indicating the slope to no longer be safe. Additionally, combining gabions with concrete minipiles could enhance the safety factor of the slope above the strengthening procedure that only relied on gabions. The analytical results indicated that the gabion arrangement with dimensions of L-W-H (1x2x0.5) m presented a higher safety factor in comparison to the L-W-H (2x1x0.5) m model. This demonstrated that a gabion with a wider width was capable of withstanding larger external forces. Horizontal (lateral) force is one of the movements that occur in landslides. Hence, by increasing the width (W dimension) of the gabion, the length of the shear plane between the gabion's base and the ground may also grow. Consequently, the shear force that opposes the lateral movement would be greater, thus enhancing the slope safety factor. Based on the assessment results of an increase in slope SF, it can be inferred that the variables of the L-W-H gabion arrangement model had a greater influence on enhancing SF compared to the influence of
